**COLE MILL TOWNES HOMEOWNERS  
ASSOCIATION  
DURHAM, NC**

**DATE:  
SEPTEMBER 4, 2025**

**FULL RESERVE STUDY**

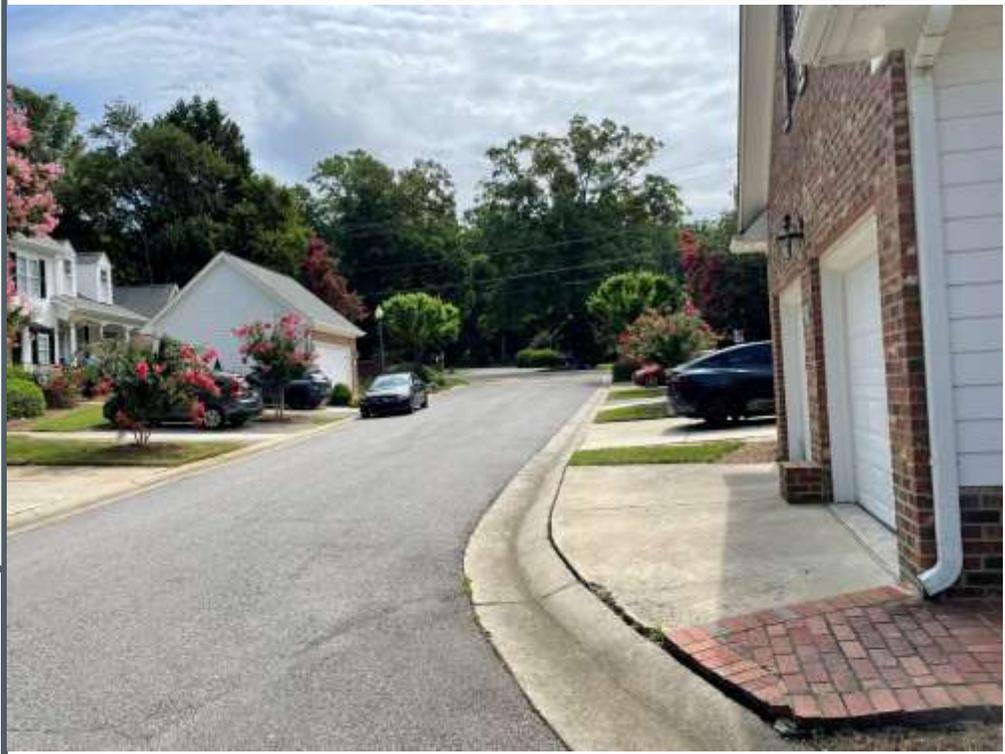
**Photo No.**  
**1**

Asphalt paved private streets.

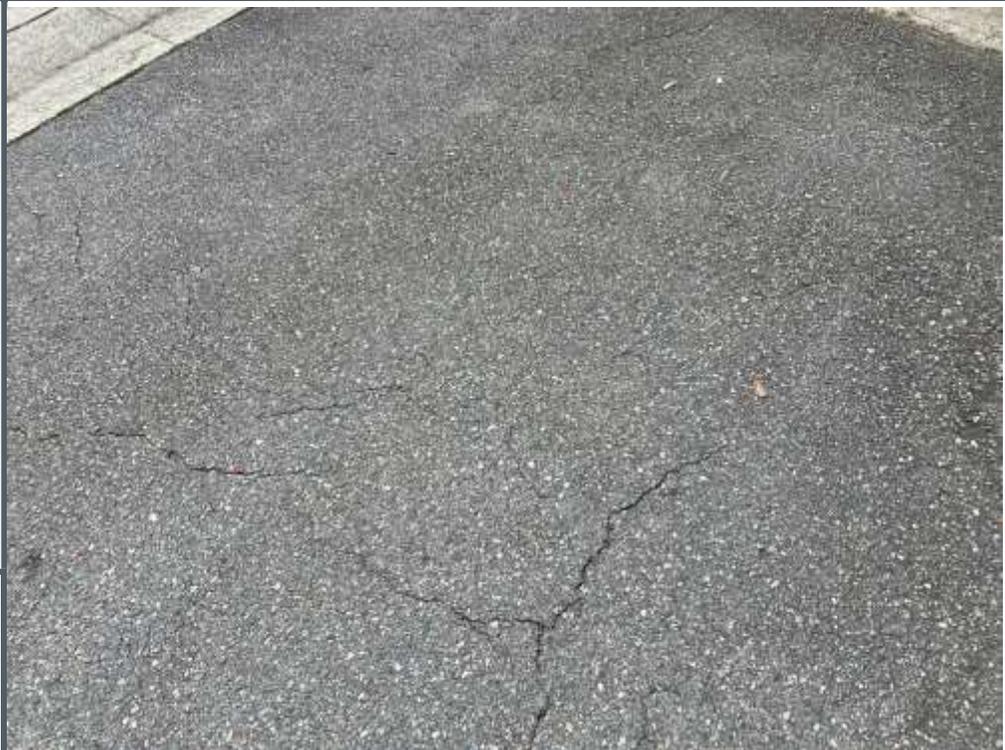
**Photo No.**  
**2**

We understand that the maintenance of the private asphalt paved streets is the responsibility of the Association. The asphalt paving generally appeared to be in fair condition at the time of inspection. Minor longitudinal and transverse cracking, fatigue cracking, surface oxidation, and exposed aggregate were noted. Typically, we recommend the application of an oil-resistant sealant to asphalt paved surfaces on an approximately 5-year cycle. At this same time, all cracks should be properly filled, patched, and sealed. We have allocated funds to reseal the pavement on a 5-year cycle beginning in 2026.

Oxidation, exposed aggregate, and minor cracking.

Assuming sealing and crack repairs occur in the interim, we anticipate the asphalt paving in the private streets and parking areas to have a total estimated useful life of approximately 20 to 25 years prior to resurfacing. We have allocated funds to resurface the current asphalt paving in 2031. This would include milling and removing the top 2” of asphalt paving throughout all paved areas, repairing base course as needed, and installing a new 2” thick layer of asphalt over all paved surfaces.

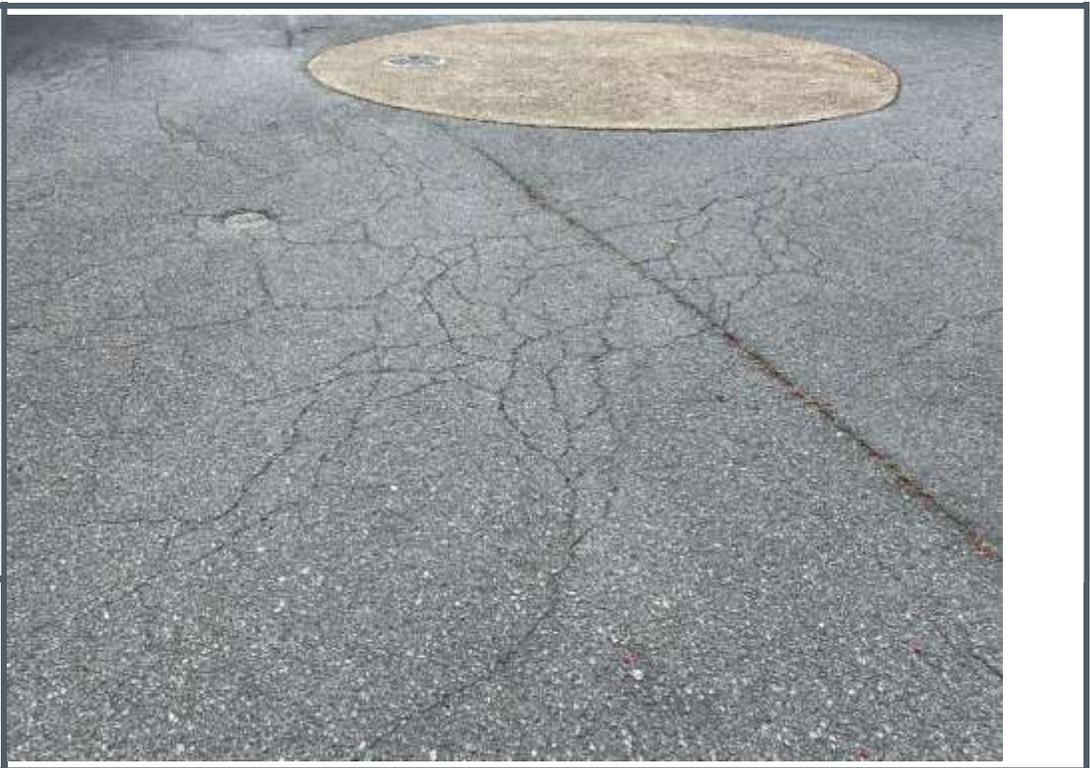
<p><b>Photo No.</b></p> <p>3</p>

<p><b>Description</b></p> <p>Fatigue cracking in asphalt pavement.</p>

We have included funds to make full depth asphalt repairs over the term. This type of repair includes sawcutting and removing the damaged/deteriorated asphalt, re-compacting the subgrade, and installing new asphalt surface materials. We have allocated funds for full depth repairs of the asphalt pavement on a 15-year cycle beginning with the seal coat project in 2026.

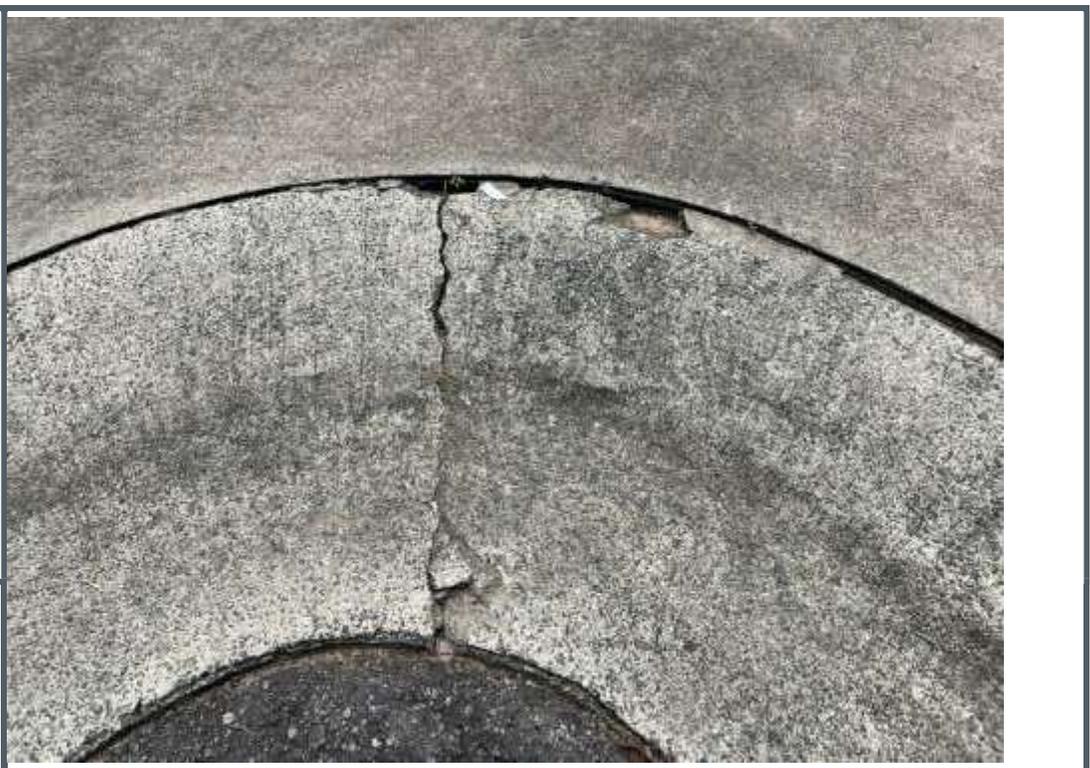
<p><b>Photo No.</b></p> <p>4</p>

The Association is responsible for maintaining the concrete walkways, brick pavers, driveways, and curbing around the private streets. The concrete flatwork and pavers generally appear to be in good to fair condition with minor cracking and settlement noted in limited areas. Over time, it is likely that cracking and/or settlement will continue to develop and worsen in the surfaces. As cracking develops, it is likely that sections of the flatwork will require repairs. We have allocated funds for repair/replacement of portions of the concrete surfaces (hardscape and curbing) around the private streets and community pathways, as needed, on an 8-year cycle beginning in 2031. Repairs may include grinding to reduce unevenness at cracking or saw-cutting, removing and replacing sections of the concrete and pavers. We have assumed isolated areas of upheaval or possible trip hazards would be repaired through an annual maintenance budget in the interim.

<p><b>Description</b></p> <p>Cracking in concrete curbing.</p>

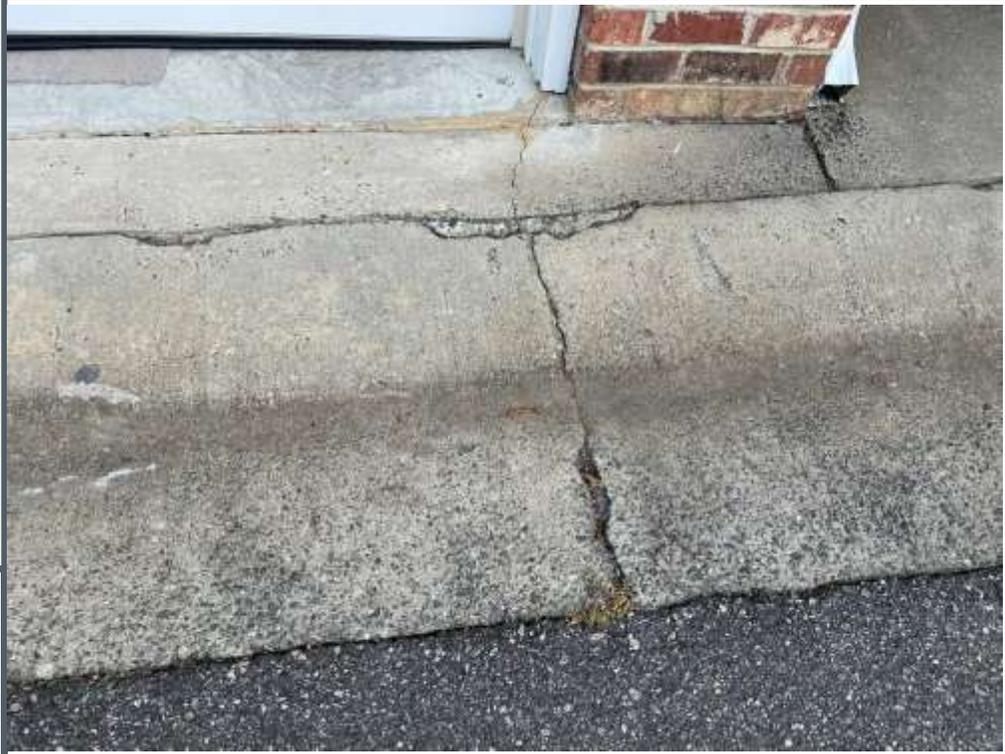
**Photo No.**  
5

Cracking and spalling in concrete.

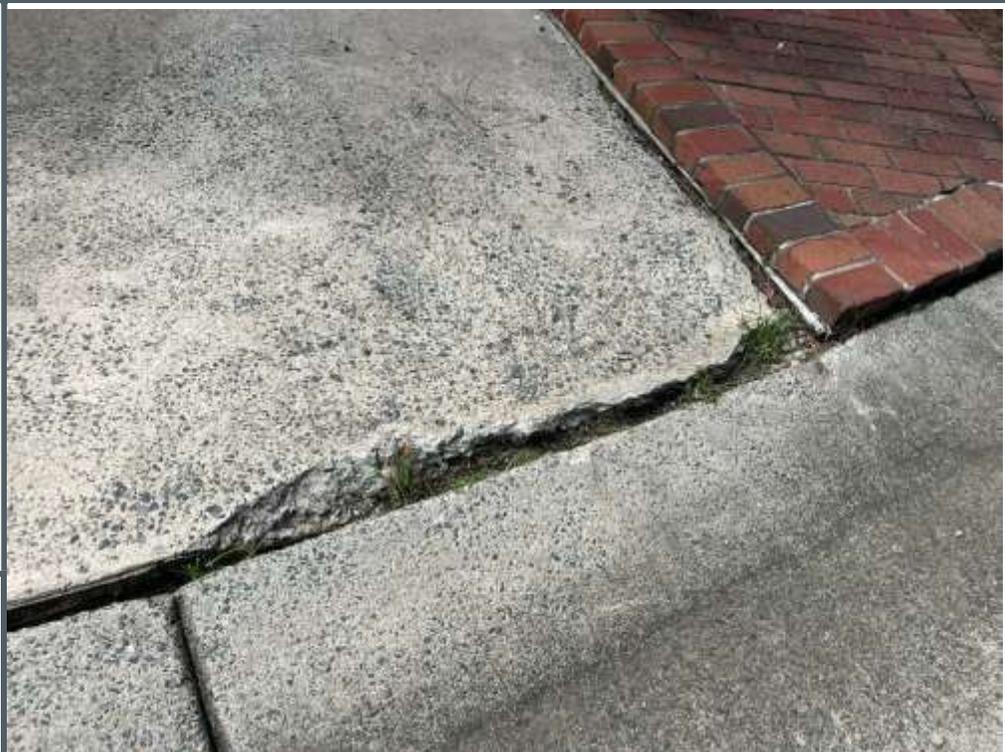
**Photo No.**  
6

Brick pavers and concrete spalling.

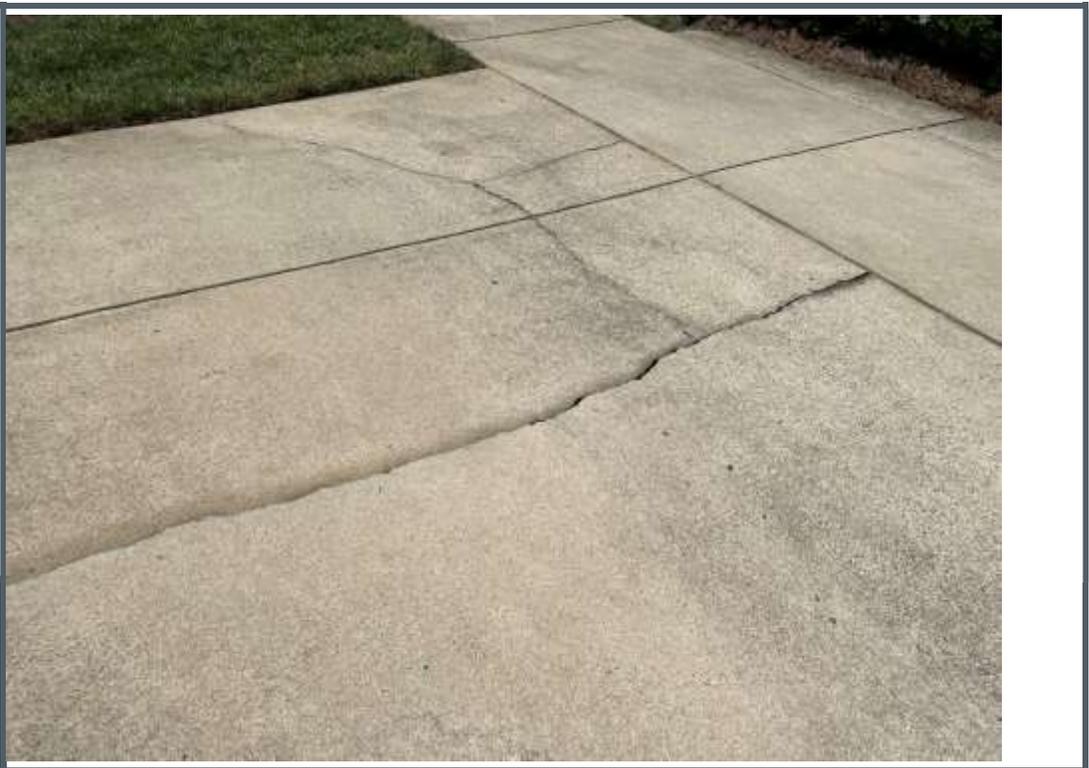
<p><b>Photo No.</b> 7</p>

<p><b>Description</b></p> <p>Cracking in concrete driveway.</p>

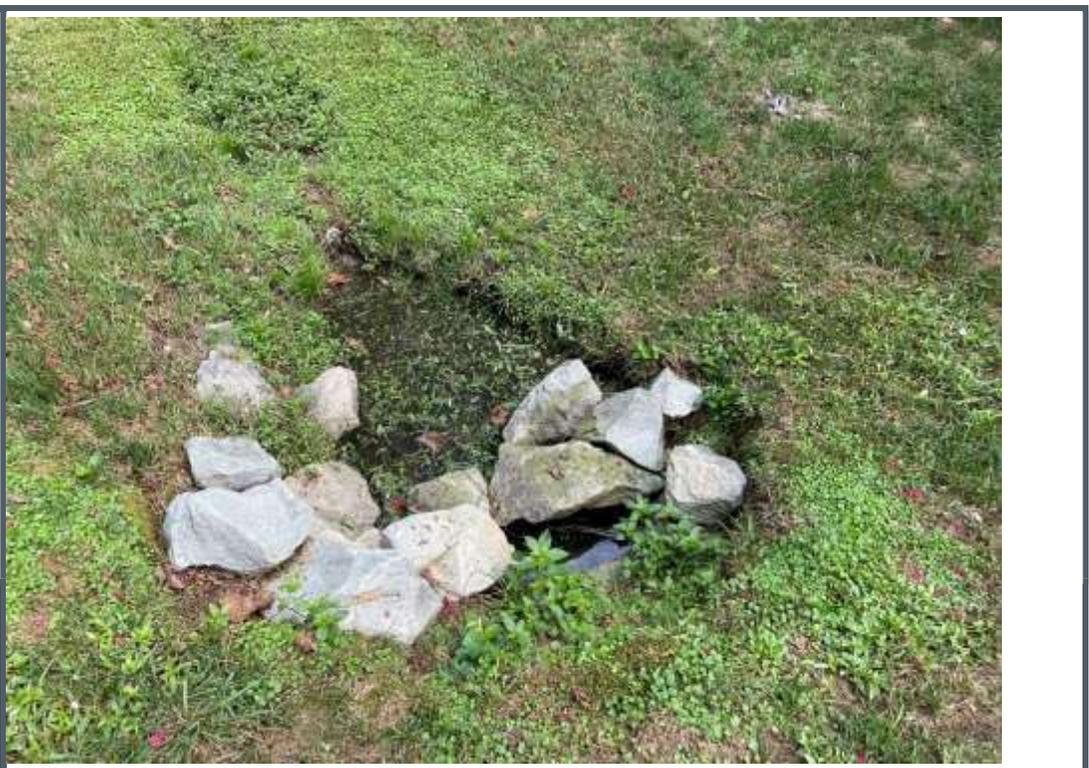
<p><b>Photo No.</b> 8</p>

<p><b>Description</b></p> <p>Riprap armored drain outlet pipe.</p>

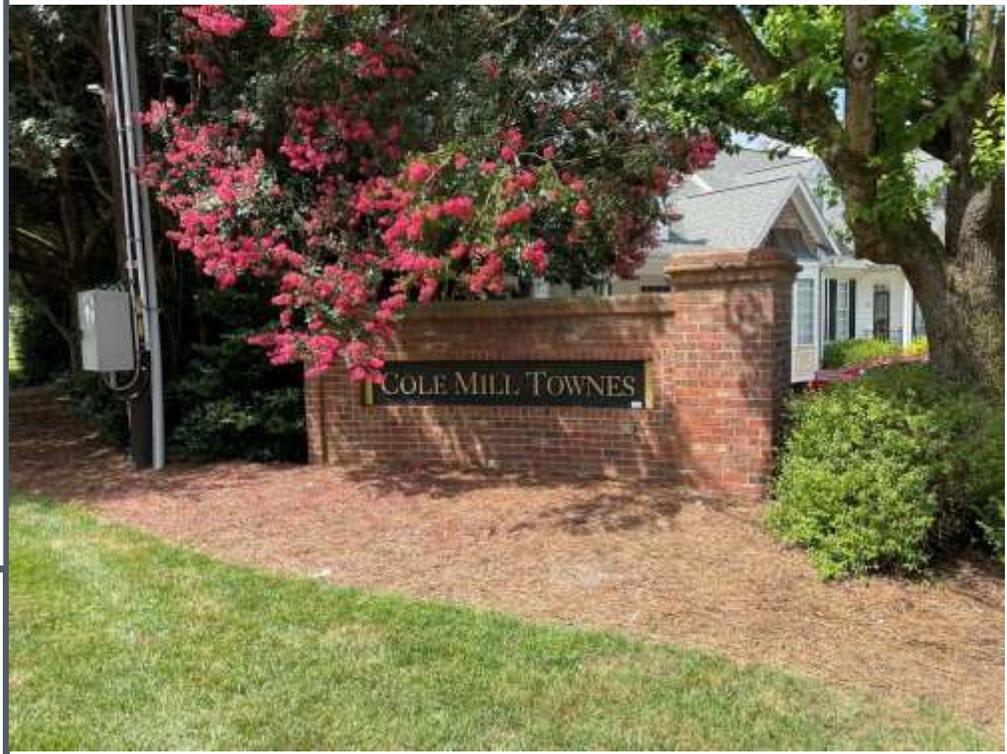
**Photo No.**  
9

Entrance monument.

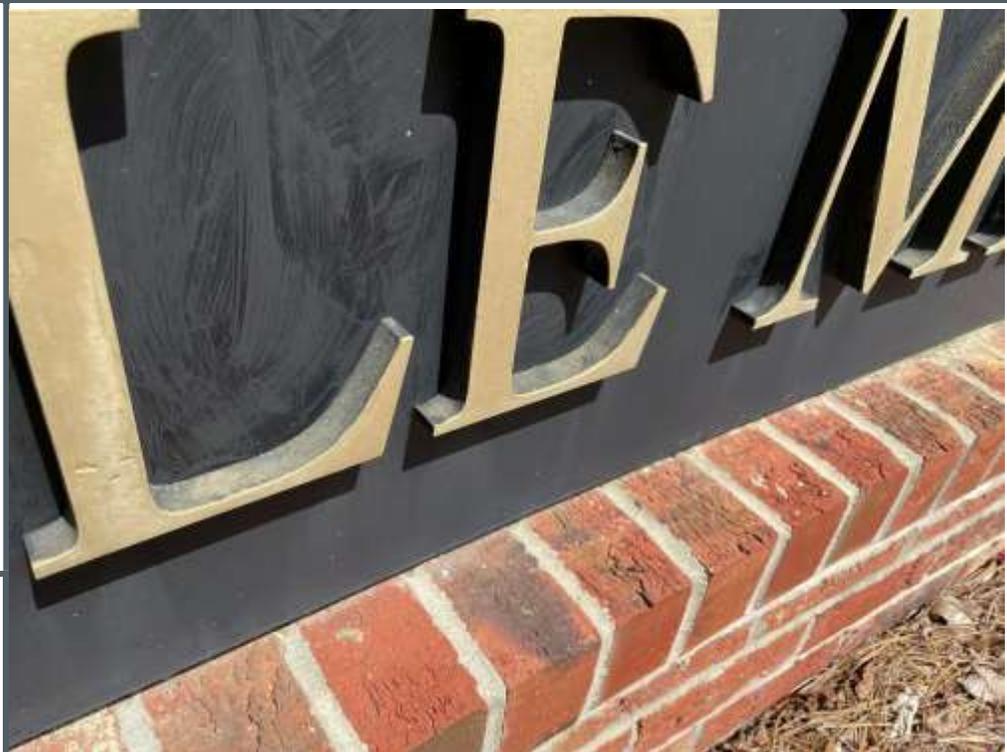
**Photo No.**  
10

Entrance monuments are located at the entrance to the community and generally consists of brick veneer masonry monument structures with a composite sign bearing the community's name. The entrance signage appeared to be in fair condition with discoloration noted. We do not anticipate a large-scale replacement project of the monument; however, refurbishment may be periodically required. Refurbishment may include replacement/repairs of the signage and repairs to the brick veneer structures. We have included an allocation of funds for repairs to the entrance monuments every 15 years beginning in 2029.

Discoloration of paint on  
entrance sign.

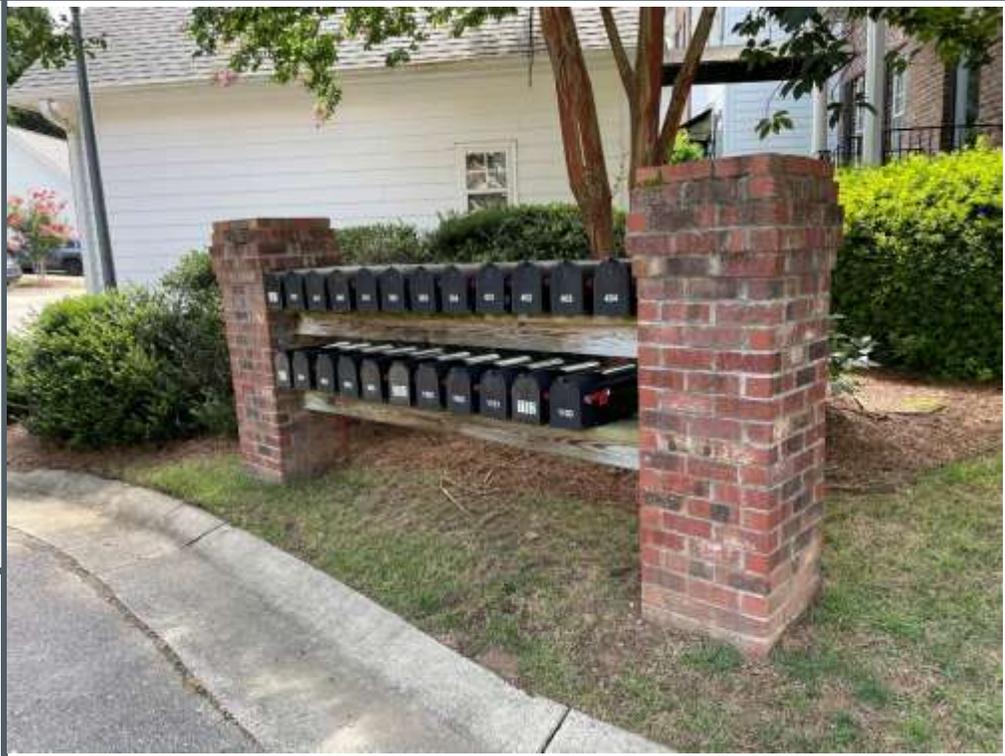
**Photo No.**  
**11**

Standard mailboxes are centrally located and fastened to wood beams between two brick veneer masonry piers. The mailboxes generally appeared to be in good condition and have a useful life of approximately 20 years prior to replacement. We have included funds to replace the mailbox kiosks beginning in 2036. We have assumed repairs to the wood framing and piers would be performed as needed and funded through the annual maintenance budget.

Community mail center.

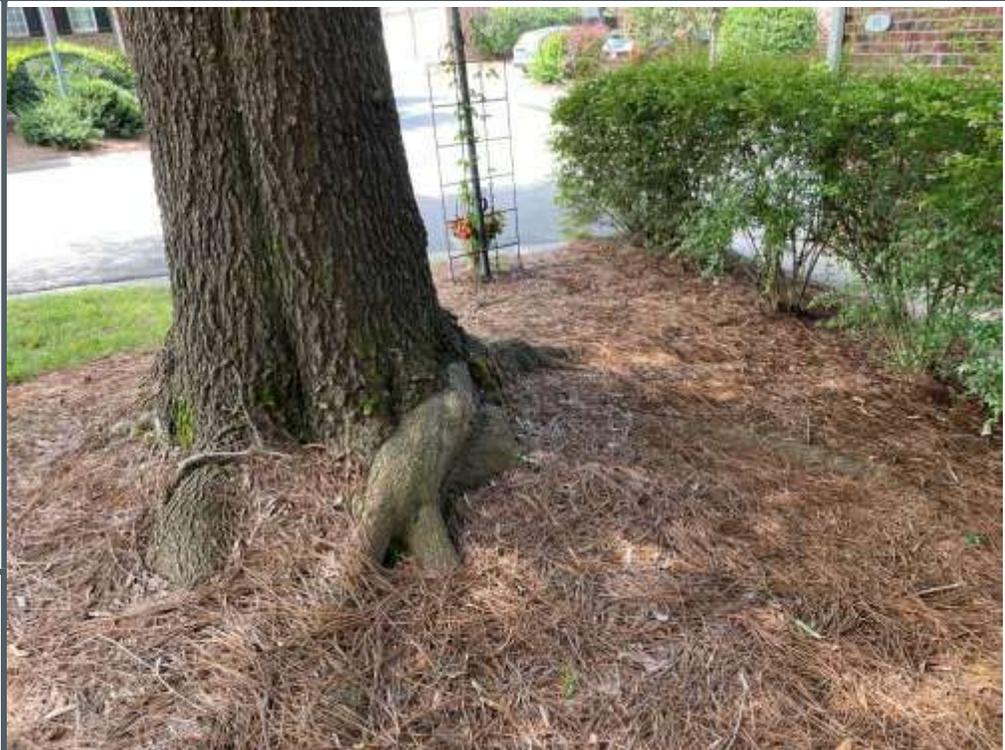
**Photo No.**  
**12**

Mature tree near building.

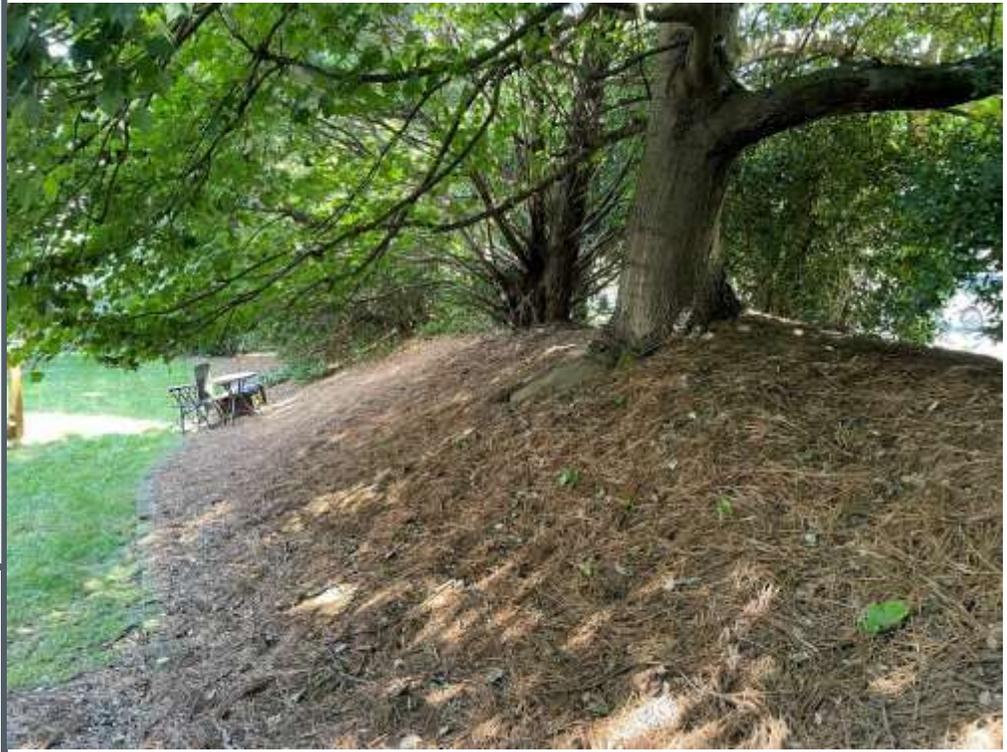
**Photo No.**  
**13**

Landscaped berm along community boundary.

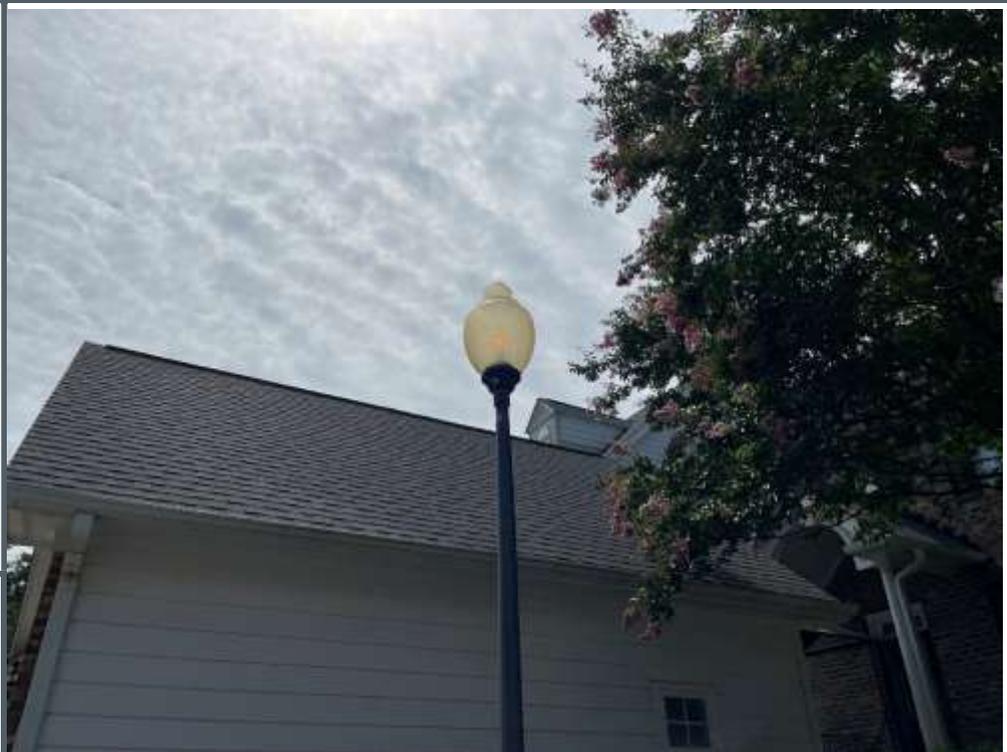
**Photo No.**  
**14**

Typical light pole in community.

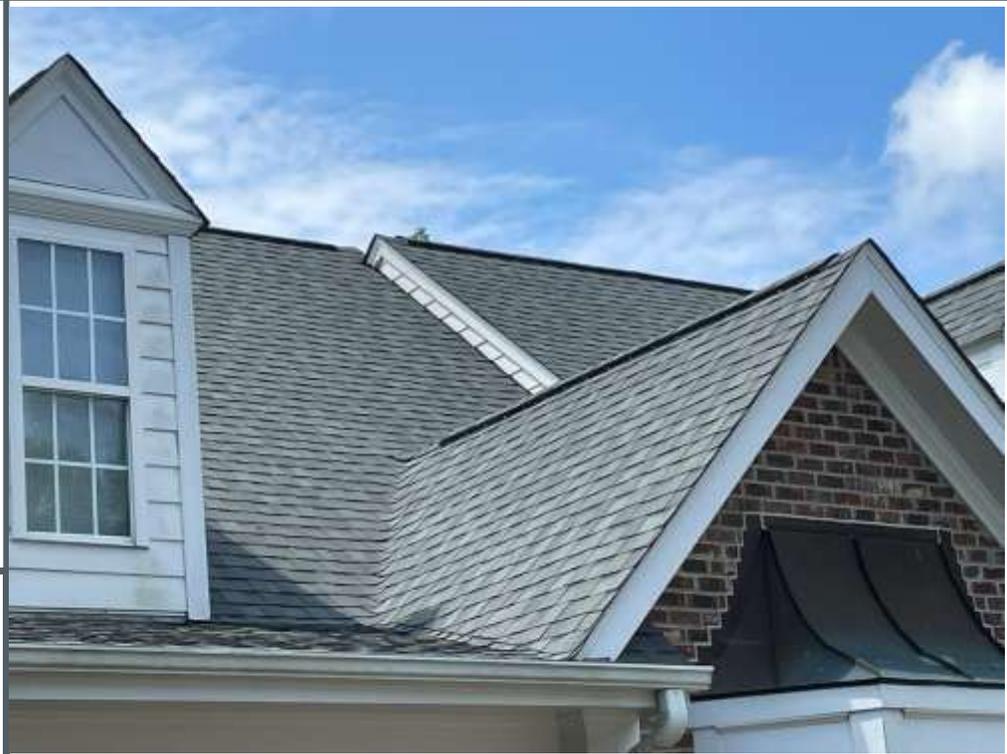
**Photo No.**  
**15**

is applied over plywood roof sheathing and appears to be in good condition. Assuming minor repairs are performed in the interim, we estimate the shingled roofing surfaces to have an expected useful life of approximately 20 to 25 years. We have included funds to replace the townhome roofs every 20 years beginning in 2043.

Architectural grade  
asphalt shingled roof.

We strongly recommend that any re-roofing project closely follow procedures outlined by the latest edition of the National Roofing Contractors Association's *Roofing and Waterproofing Manual*. A re-roofing sequence should include removal of the existing roofing material, replacement of any inadequate roof sheathing, replacement of any damaged flashing, and replacement of drip edge components. Periodic minor repairs to the vent boots, flashing and gutters will likely be required in the interim prior to full roof replacement. Minor repairs to correct roof leaks in the interim will also likely be required on an annual basis.

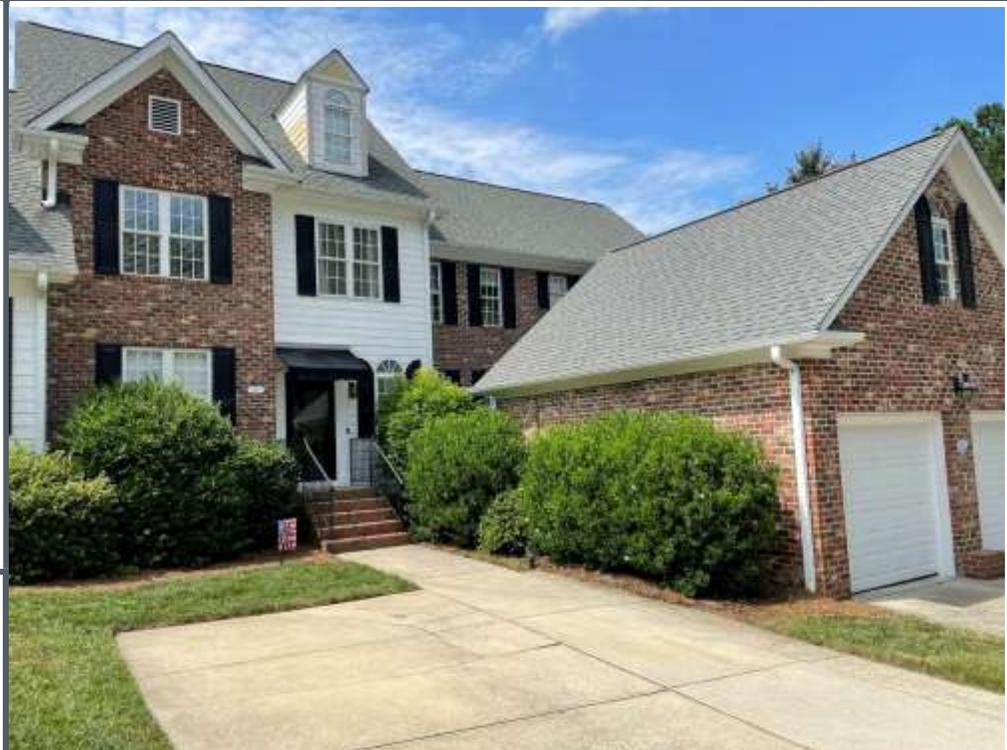
**Photo No.**  
**16**

General view of  
townhome building and  
garage.

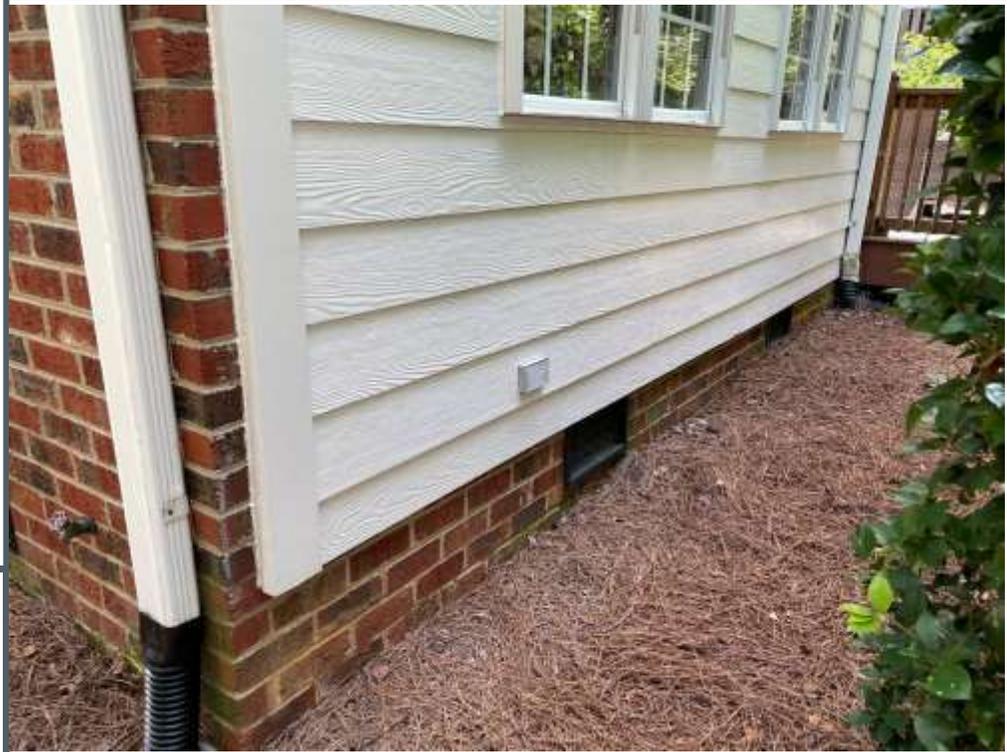
**Photo No.**  
**17**

Fiber cement siding.

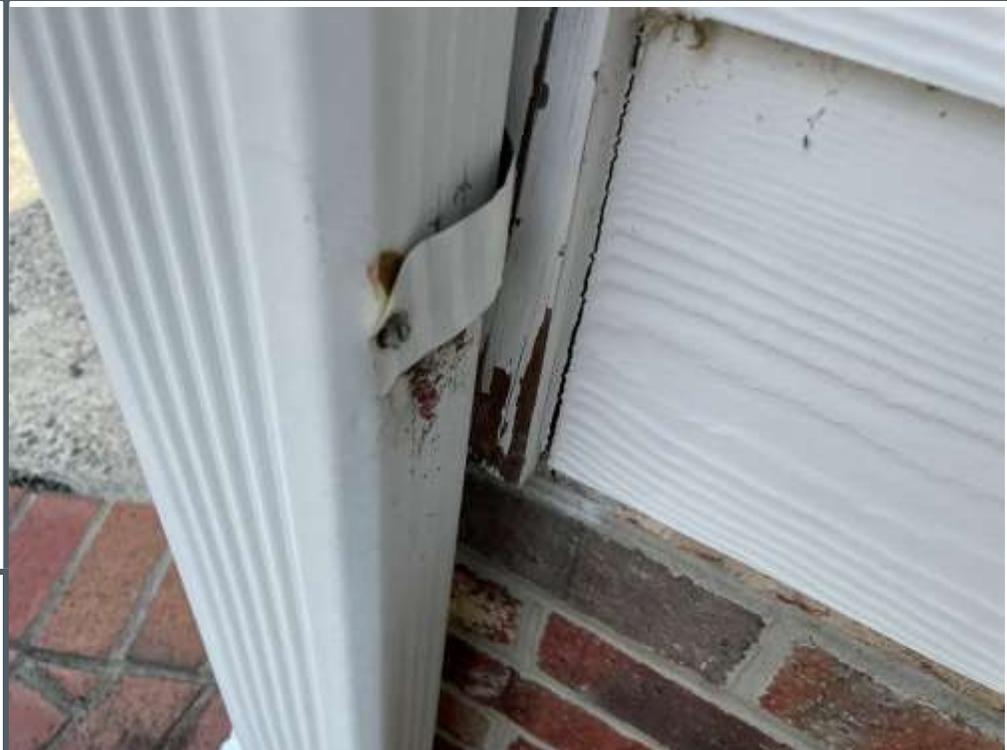
**Photo No.**  
**18**

Flaking paint on wood trim near downspout.

The painted siding and trim components on the exterior of the buildings generally appeared to be in good condition. Note that painting of the townhome buildings was being performed during the inspection. To maintain a clean, bright appearance and protect the exterior finishes, we recommend re-painting the siding, trim, and accent components on an approximate 8-year cycle. During each painting project, any damaged components should be repaired and the transitions in the materials and any seams should be re-caulked. We have allocated funds to paint, repair and re-caulk the painted exterior components every 8 years beginning in 2033.

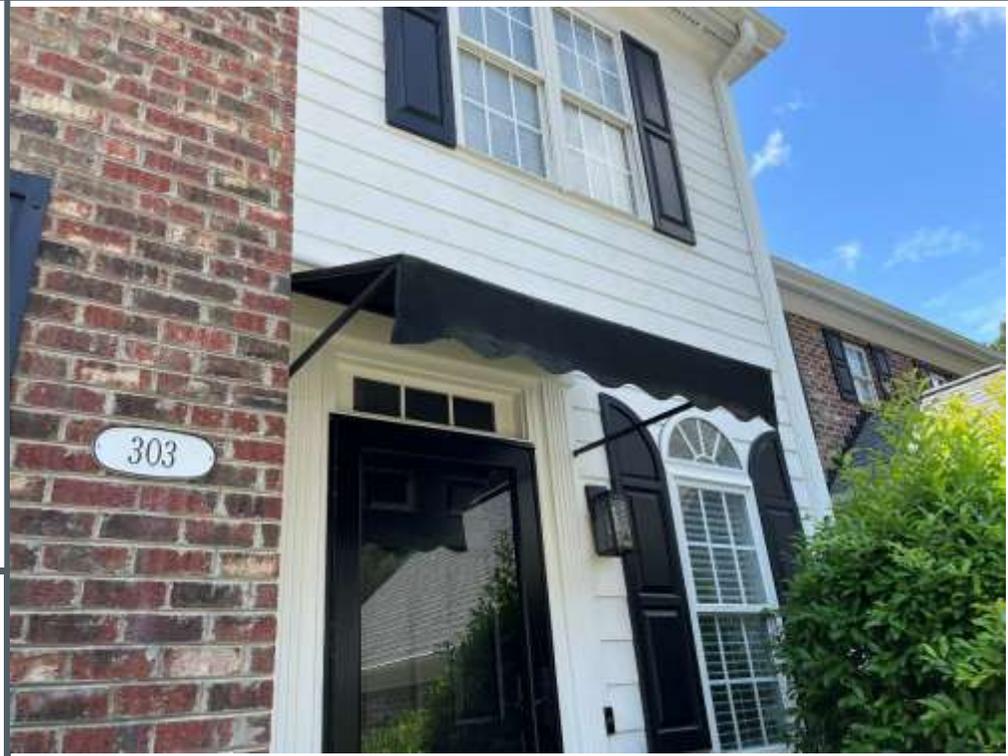
**Photo No.**  
**19**

Fabric awnings on metal frames are installed over some of the front entrances and one tent awning was noted between a detached garage and the townhome building. The awnings appeared in serviceable but aging condition; however, we understand the Board intends to replace the awnings this year. We have included funds to replace the fabric awnings every 12 years beginning in 2037. The metal frames will not likely require replacement during the term, and we assume that any minor repairs would be performed as an annual maintenance task when needed.

Front door awning.

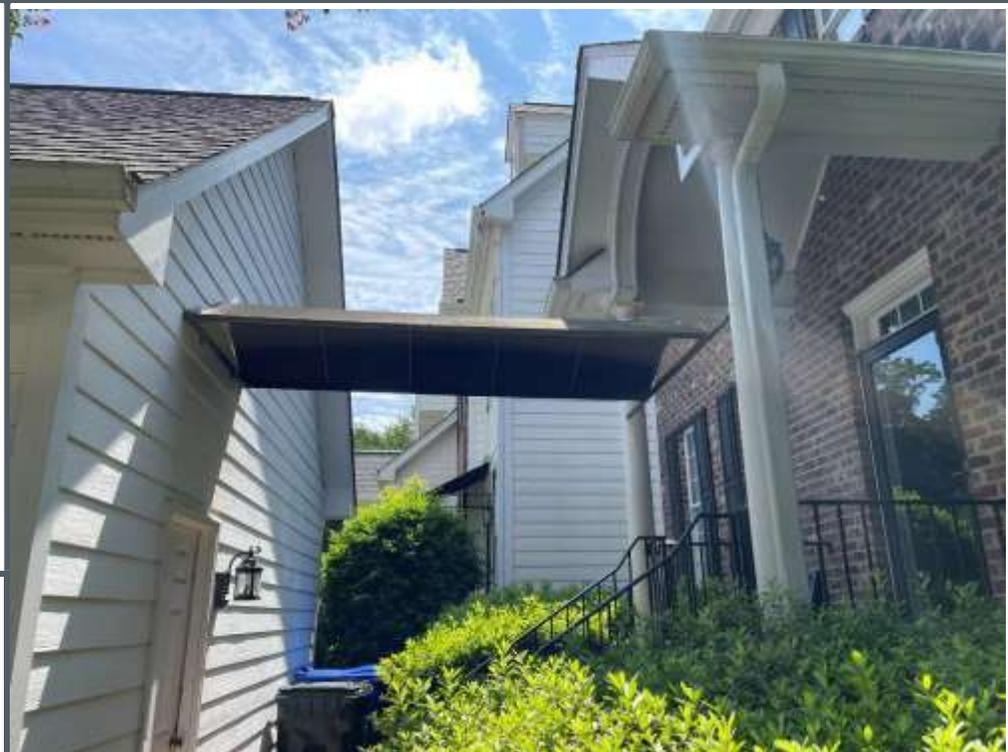
**Photo No.**  
**20**

Tent awning.
