FULL RESERVE STUDY

*THE GABLES CONDOMINIUMS
CHAPEL HILL, NC*

Prepared for:
THE GABLES UNIT OWNERS ASSOCIATION
&
ALLENTON MANAGEMENT
DURHAM, NC

Prepared by:
CRITERIUM – GILES ENGINEERS
1150 SE MAYNARD RD., SUITE 220
CARY, NC 27511
NC LIC. No. C-2871
(919) 465-3801

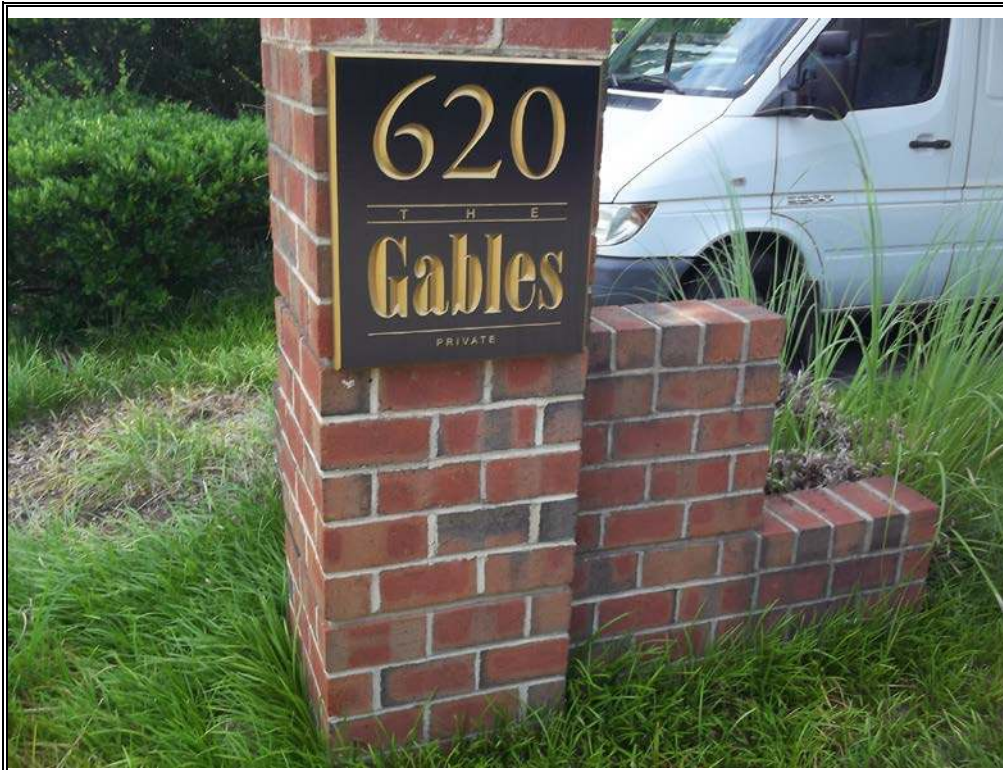
Photo Number
1

Description:
Entrance signage

Two brick entrance monuments with composite plaques and ground lighting are located at the street entrance. The signage is in good condition, but should be replaced on an approximately 10 year cycle. We have included funds for the next replacement in 2024.

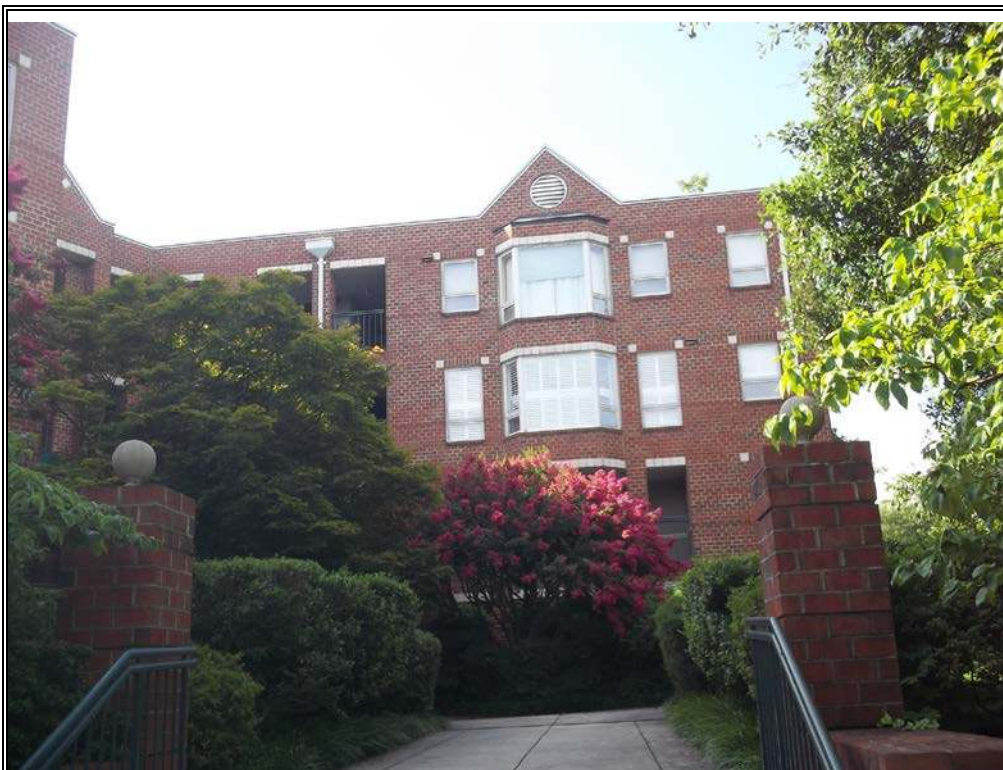
Photo Number
2

Description:
Front elevation

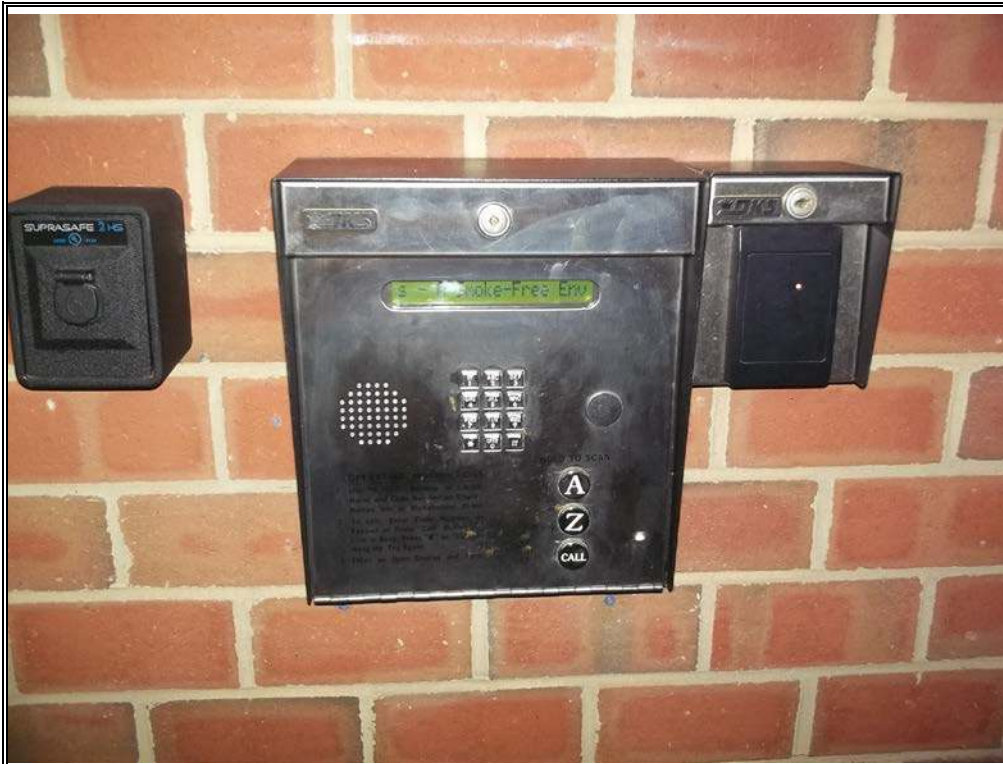
Photo Number
3

Description:
Secured access and
intercom system

The building includes a DoorKing secured entry system at the entrances. We have allocated funds for future repairs of the electronic locks and to replace/upgrade the access control systems on an 8 year cycle beginning in 2022.

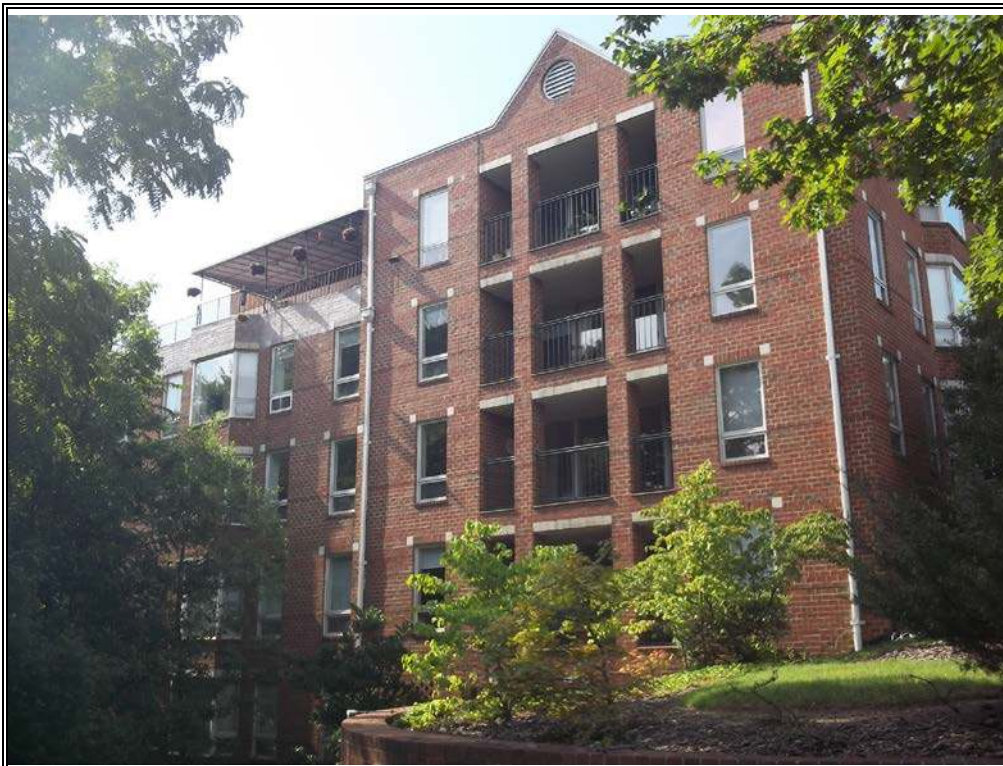
Photo Number
4

Description:
Side elevation

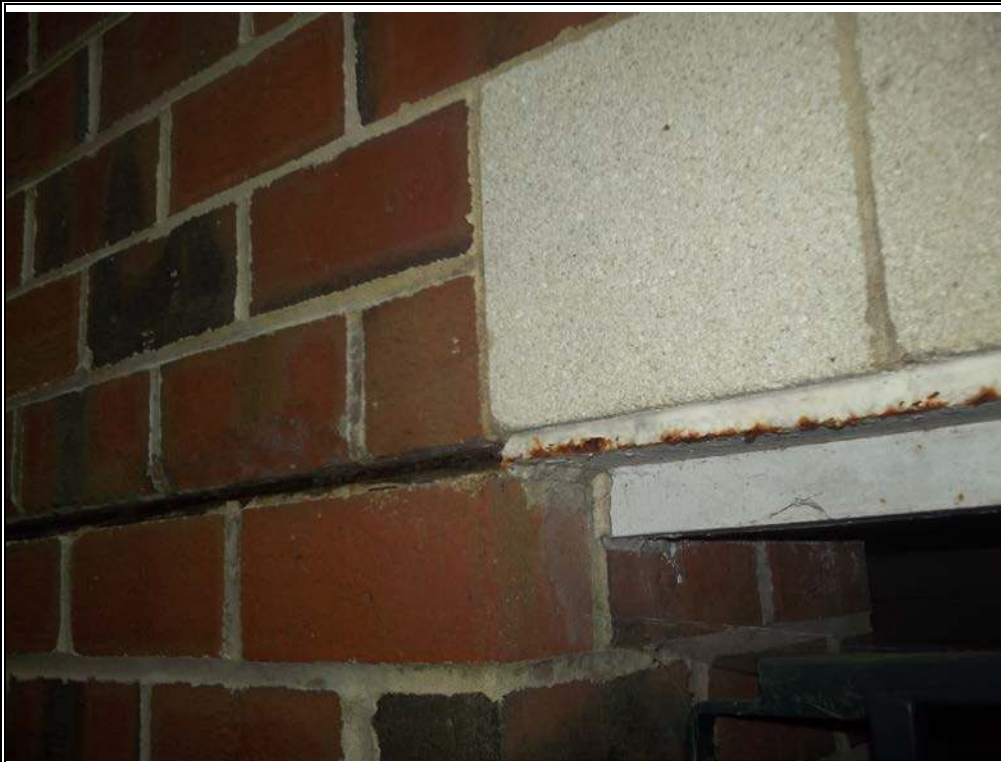
5

The building exterior is constructed primarily in a brick masonry veneer. The majority of the exterior surfaces are in good condition with minimal cracking noted. We noted loose mortar caused by corrosion and expansion of the steel lintels above the windows adjacent to the main entrance. We have provided funds to repair sections of the brick veneer, repair and paint the steel lintels, and replace caulking/sealant at lintels and around windows every 6 years beginning in 2016.

Description:
Mortar missing at
steel lintel
corrosion

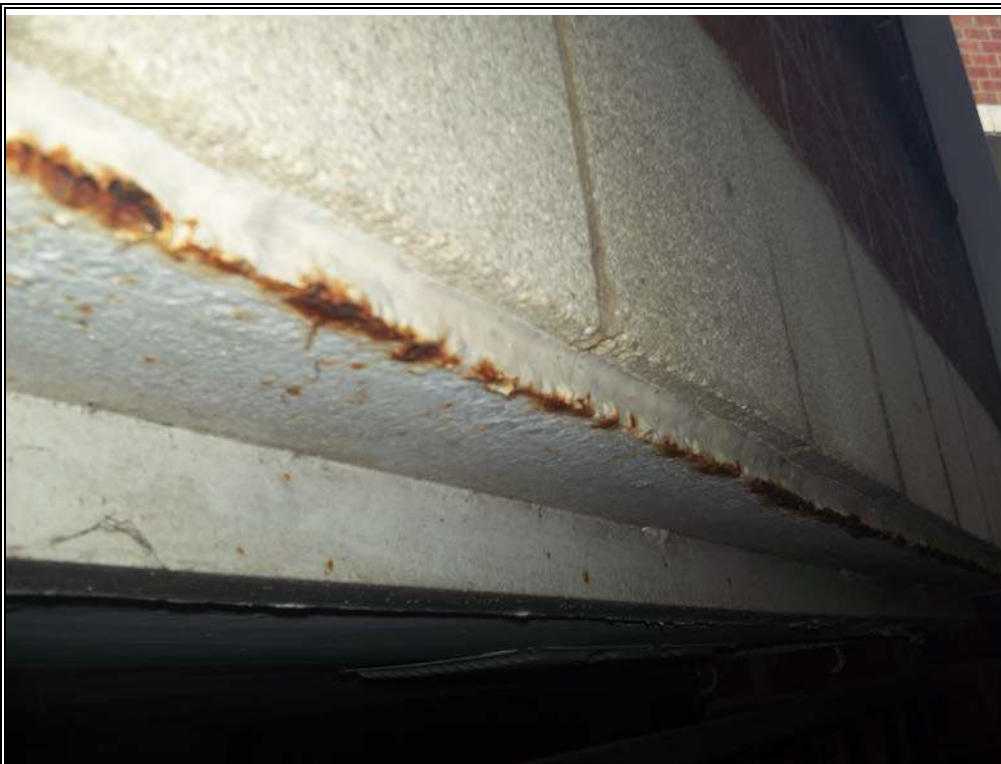
Photo Number

Description:
Steel lintel
corrosion

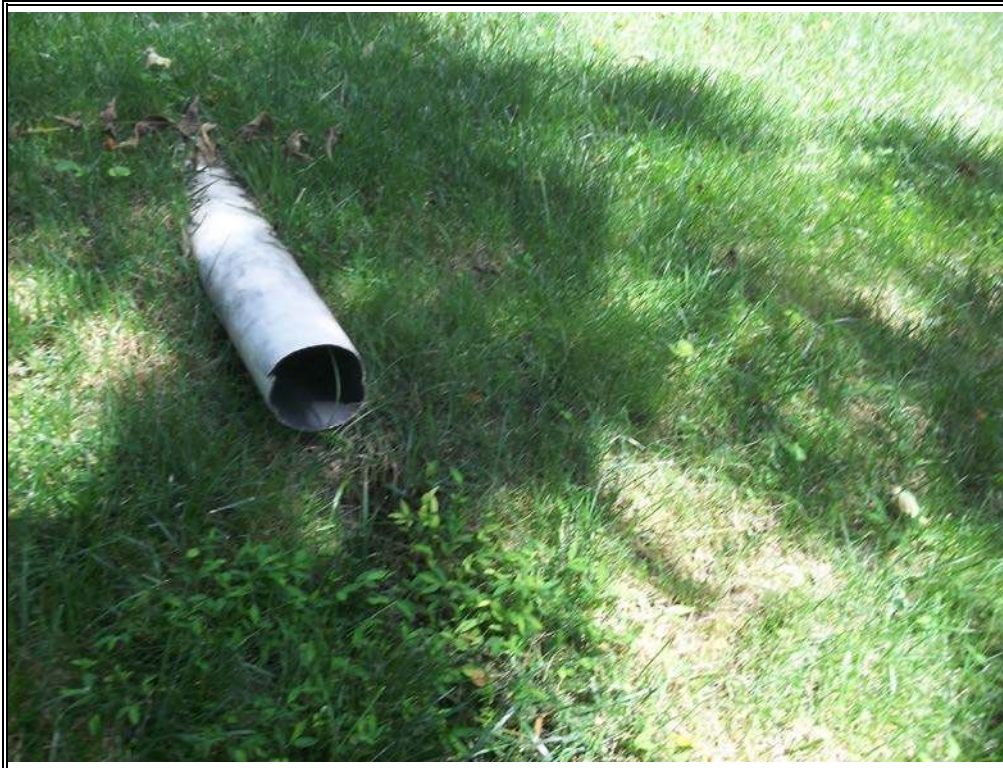
Photo Number
7

Catch basins and piping are located in the parking areas, and downspout pipe extensions were noted around the building. We observed erosion at the outlet of the pipe extension at the southwest corner of the building along the steep slope. We have included funds for repair and maintenance of the storm system every 5 years beginning in 2017, which will likely include flushing of the pipes, replacement or installation of small drainage systems, or stabilizing areas of erosion.

Description:
Minor erosion at
rear of building
near outlet of
downspout pipe
extension

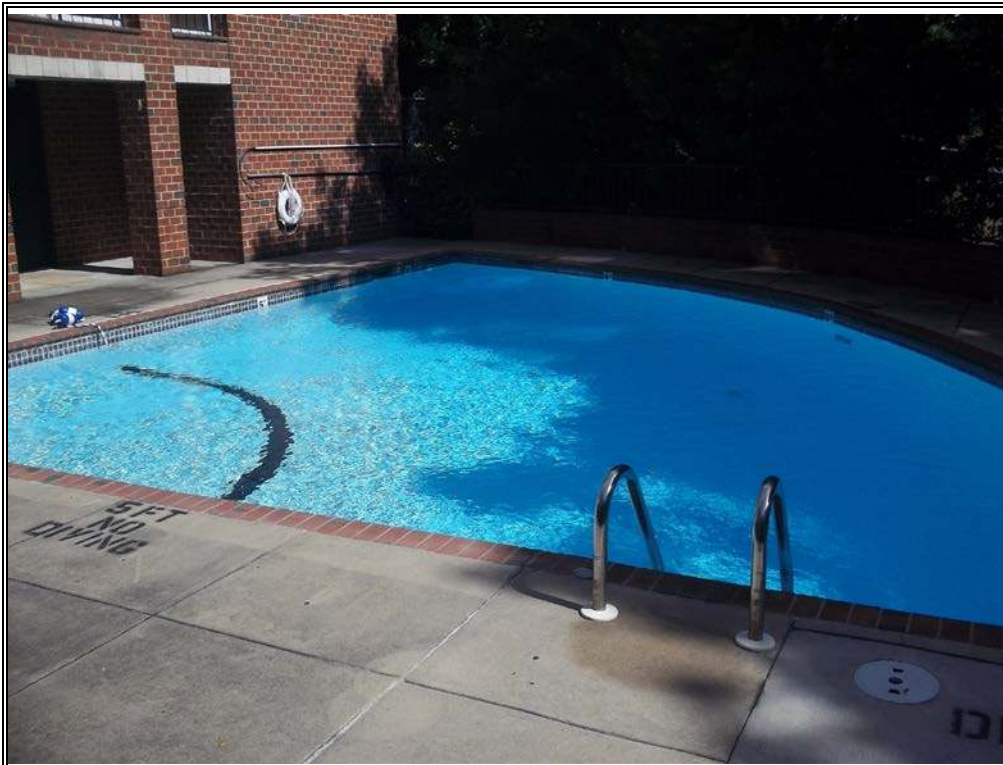
Photo Number
8

Description:
Overall pool

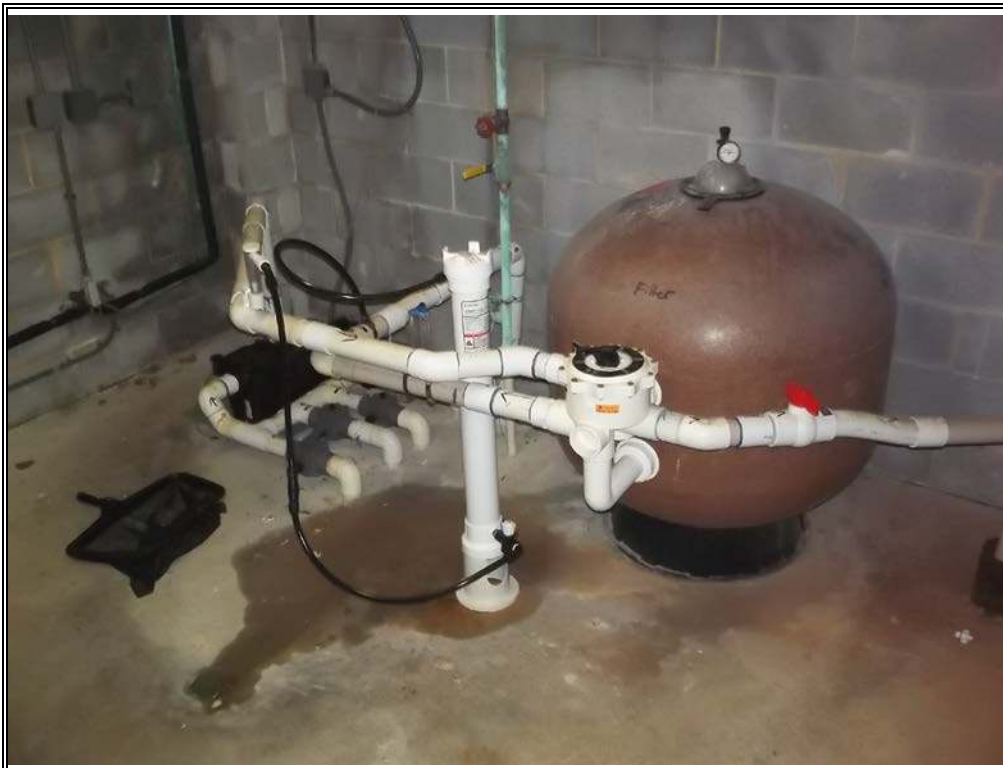
Photo Number
10

Pool equipment consists of a Triton TR-140 sand filter and Century 2.25-Horsepower pump that was operational at the time of inspection. There was moderate corrosion of the copper tubing, likely from the corrosive nature of the chemicals in the room. These components are generally replaced as they fail. We have allocated funds to replace components of the pool pump and filtration system every 4 years beginning in 2019.

Description:
pool pump and
filtration
equipment

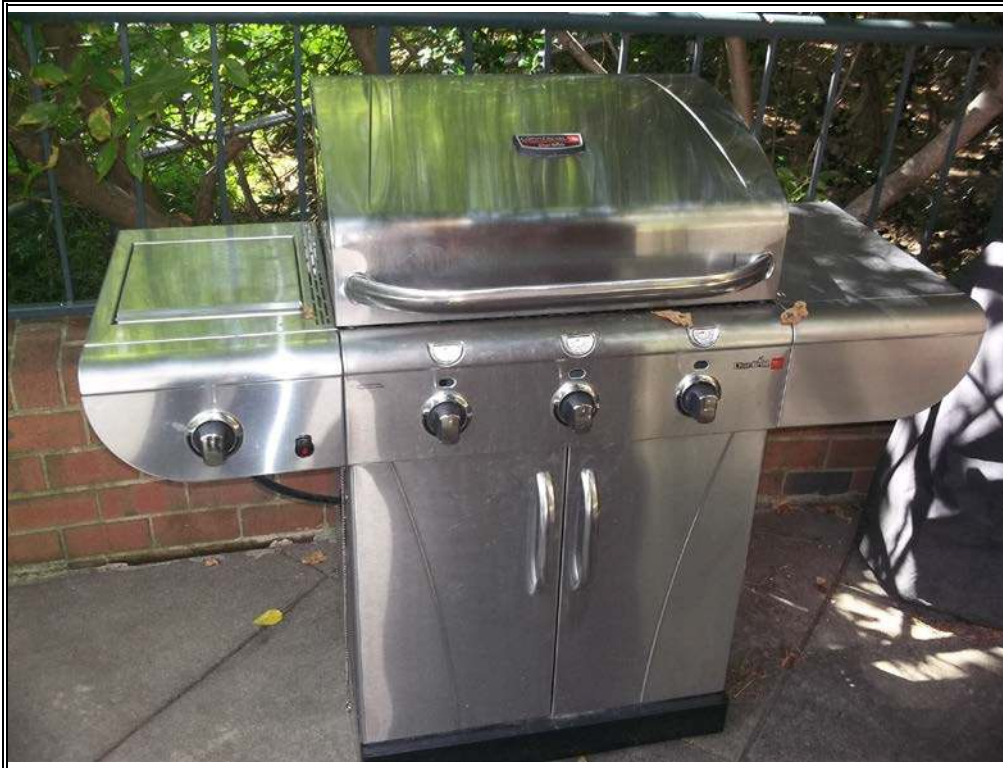
Photo Number
11

Description:
Propane grill

We have provided funds to replace the Charbroil propane gas grill every 6 years beginning in 2019.

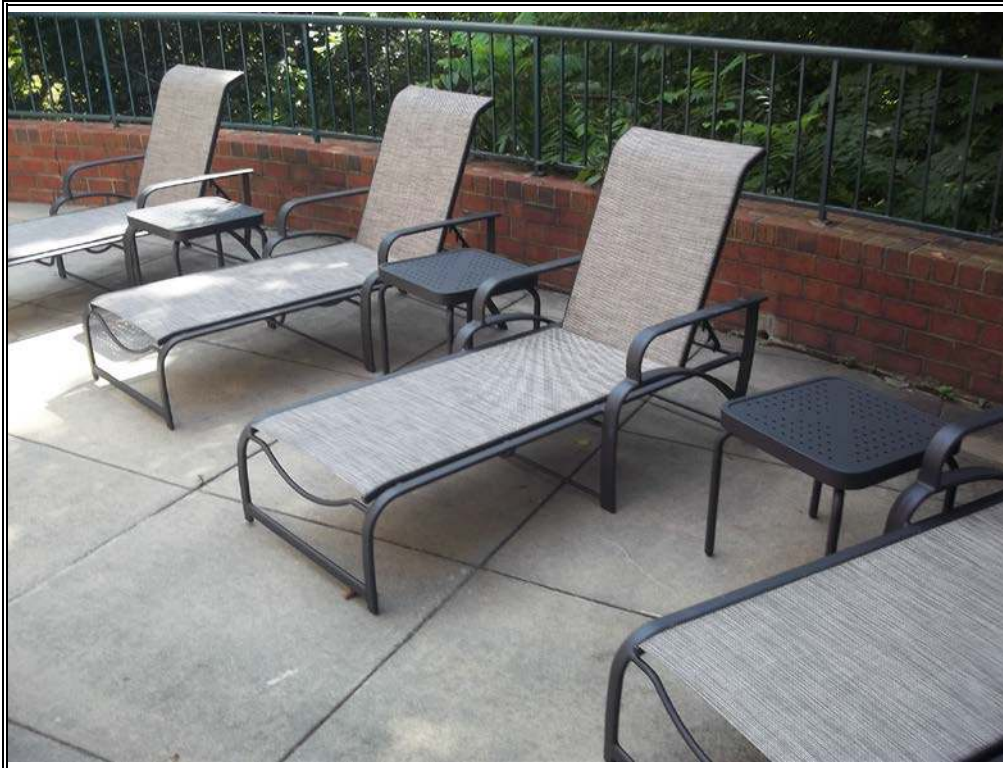
Photo Number
13

Description:
Typical pool
furnishings

Pool and outdoor furniture consisted of plastic and outdoor fabric chaise lounges, chairs, and tables, which appear to be in good condition. We have budgeted for replacement of the furniture every 12 years, beginning in 2024. The fund allocation would also include replacing the pool ladders and rails.

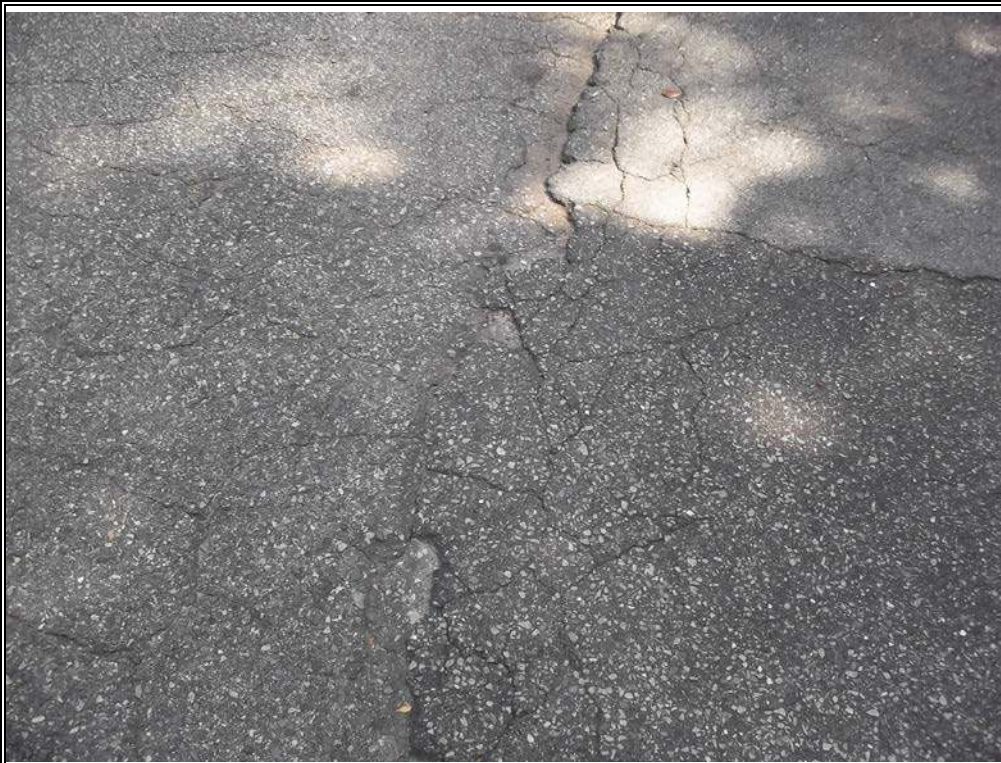
Photo Number
16

The asphalt paved parking area does not appear to have a previous sealcoat, and is generally fair condition. Sections of alligator cracking and some minor isolated cracking were noted in the asphalt paving.

Description:
Typical cracking
in asphalt
pavement

Typically, we recommend the application of an oil resistant sealant to all asphalt paved surfaces on a seven year cycle. At this same time, all cracks should be properly filled, patched, and sealed. We have allocated funds to seal, stripe and repair cracks beginning in 2016.

If sealant and crack repairs are accomplished in the interim, we anticipate the asphalt paving in the community to have an estimated useful life of approximately 20-25 years. We have allocated funds to resurface the asphalt paving in 2024. In order to maintain the drainage pattern and prevent ponding along the curb and gutter, we recommend milling of the previous asphalt layer. The resurfacing includes milling of the top 1-1/2" surface.

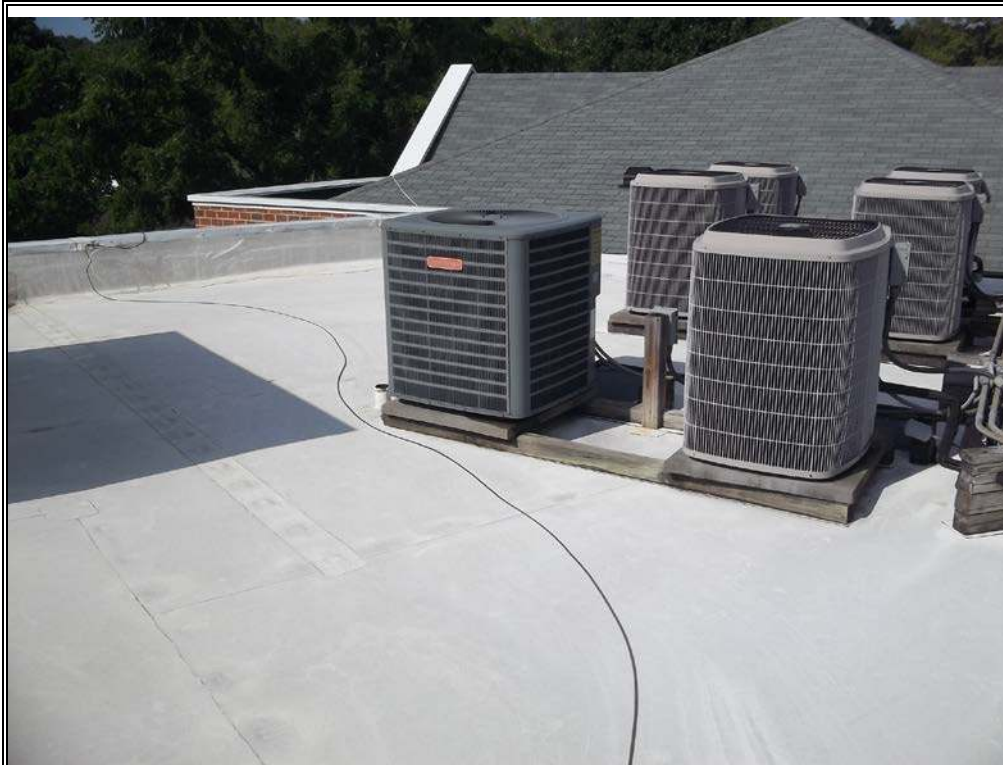
Photo Number
18

The building roof is lightly pitched toward roof drains/scuppers that route stormwater through piping/downspouts to the municipal storm sewer system. The building roof is predominately clad in a thermoplastic olefin (TPO) membrane. Sloped portions are covered in an asphaltic fiberglass, 3-tab shingle. The pool shelter also includes a shingled roof. The TPO roof was reportedly installed in 2000, while the shingles were last replaced in 2004. Typically, these types of roofing systems have expected useful lives of approximately 20-25 years, and we have allocated funds for replacing the TPO roofing in 2022 and the shingles in 2025. Limited pitched areas of the roof are clad in copper roofing. We do not anticipate the copper roofing sections will require replacement during the term of this study.

Description:
TPO membrane on
rooftop

We strongly recommend that any re-roofing project closely follow procedures outlined by the National Roofing Contractors Association's *Roofing and Waterproofing Manual*, Fifth Edition. A re-roofing sequence should include removal of the existing roofing material, replacement of any inadequate roof sheathing and the replacement of any damaged flashing. Re-roofing would also include repairing and replacing roof drains and guttering as needed.

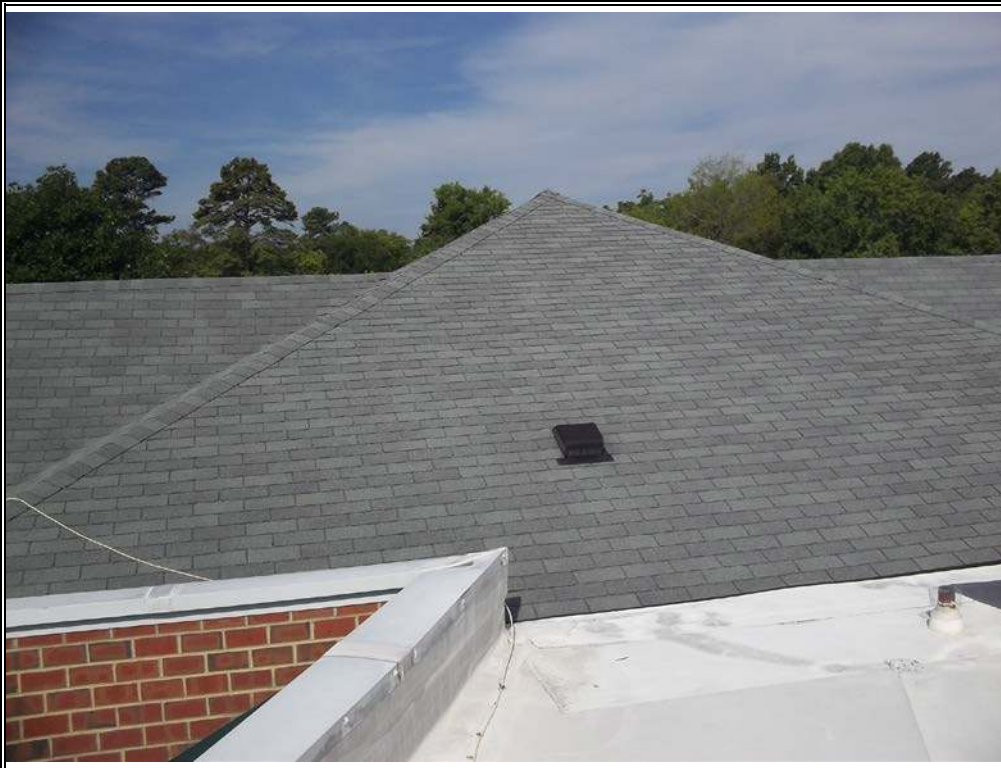
Photo Number
19

Description:
Shingle roofing on
sloped portions

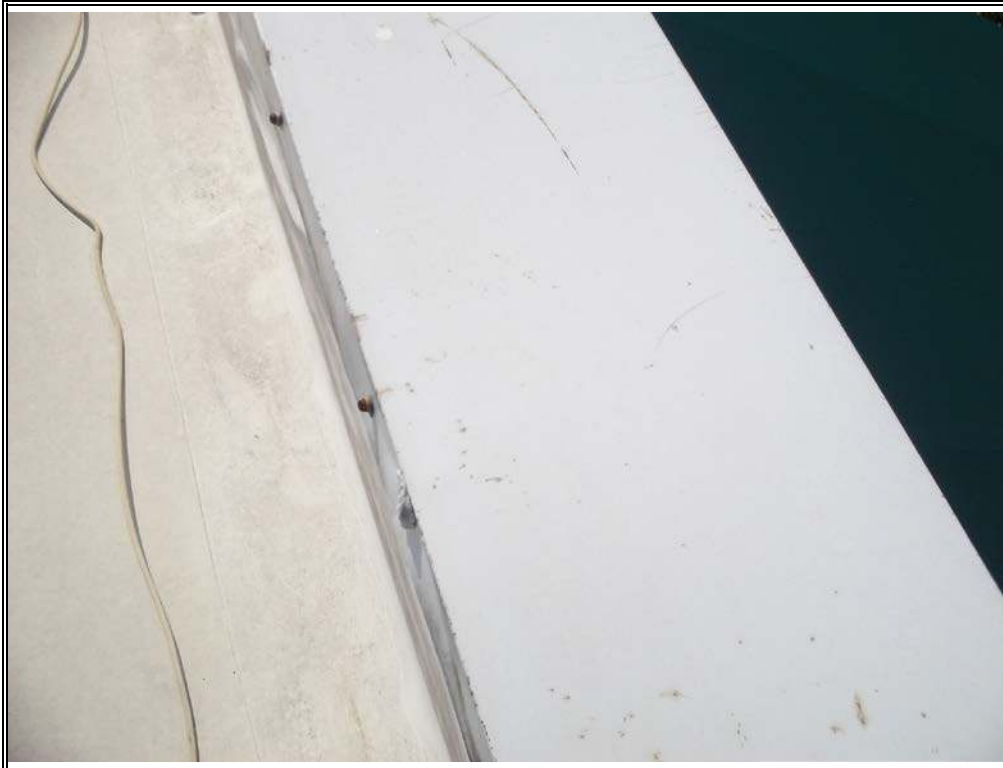
Photo Number
21

Description:
screws backing out
at sections of metal
coping on parapet
wall

Minor repairs to the flashing, parapet cap flashing and roof penetrations will likely be required in the interim; we have assumed these minor repairs would be funded from an annual maintenance budget.

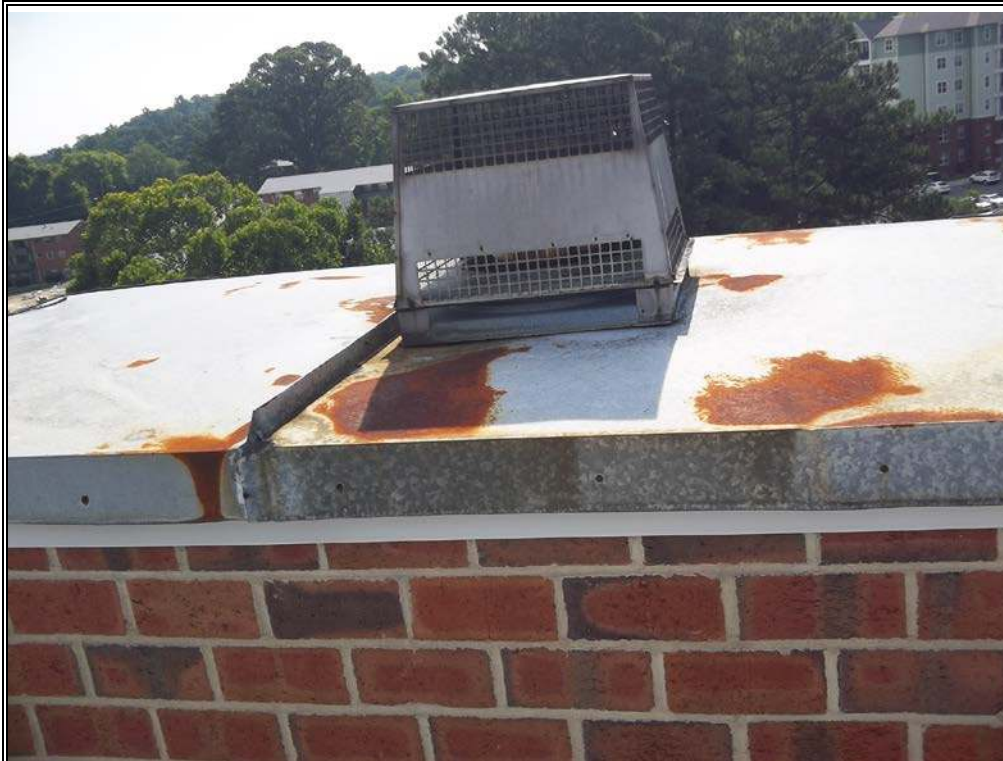
Photo Number
22

Description:
Corrosion on
galvanized
chimney cap

We have included funds to replace the large galvanized chimney cap when the TPO membrane is replaced, and at the same cycle, beginning in 2022.

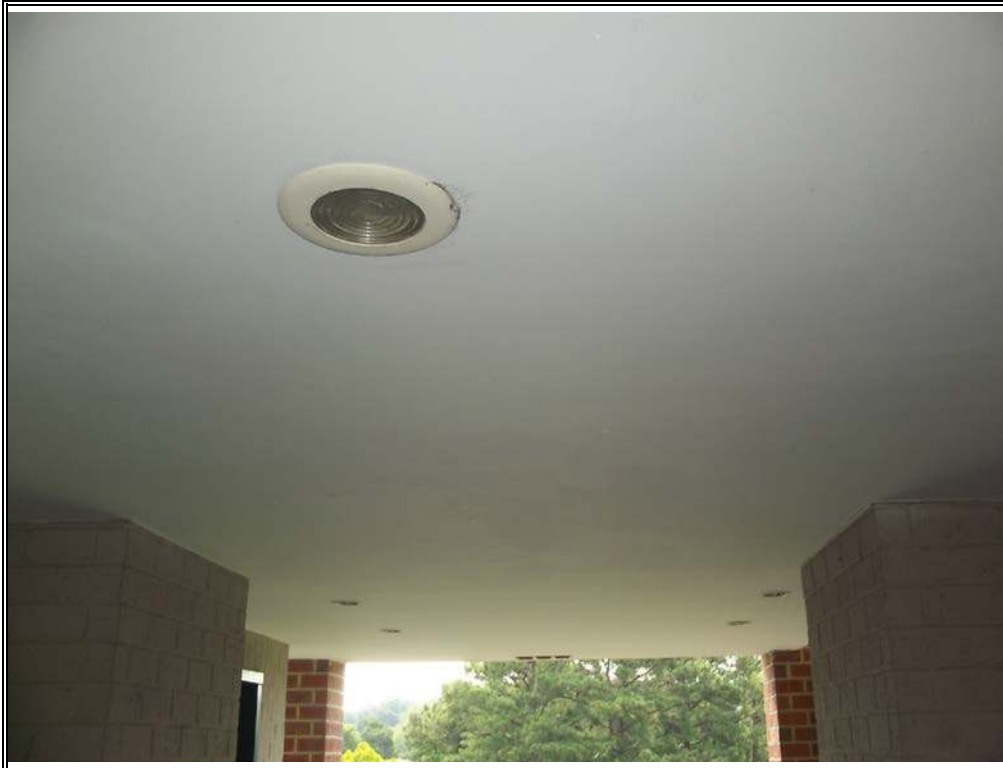
Photo Number
23

Description:
Typical recessed
can light fixture on
drywall ceiling

The corridors, entrance, and common areas include wall sconces and recessed can lighting. These lighting fixtures generally appeared to be in good condition. We have allocated funds for their replacement on a 20 year cycle beginning in 2026. We have assumed that the florescent light fixtures would be repaired as needed through an annual maintenance budget.

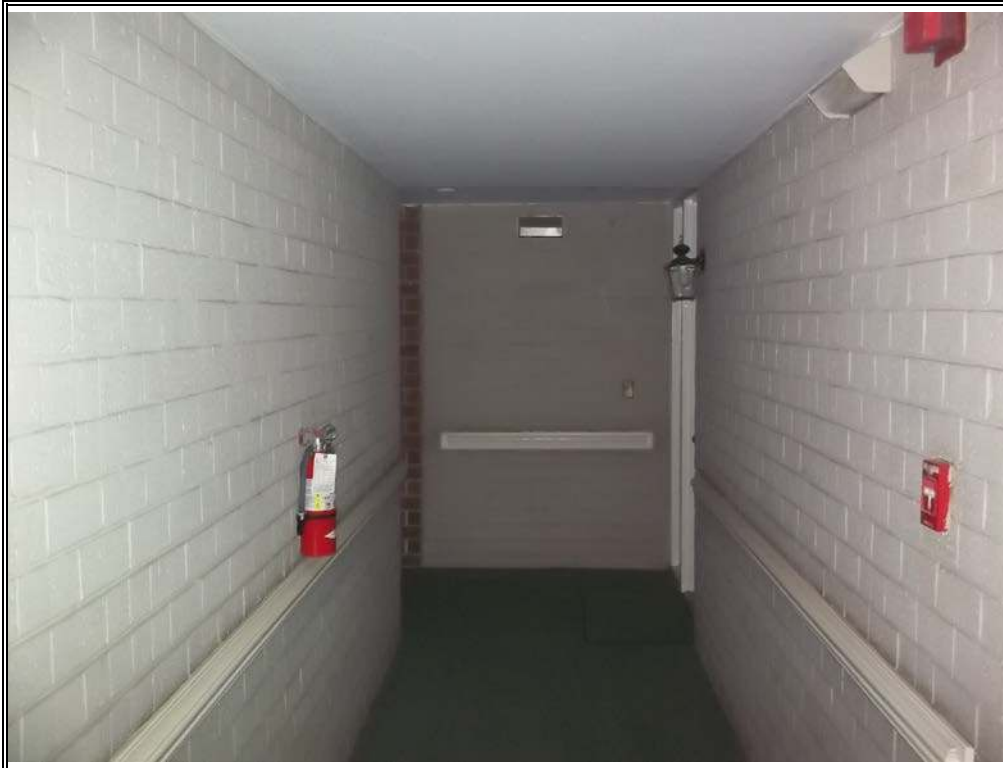
Photo Number
25

Description:
Corridor; fire
alarm pull

The life safety fixtures including smoke detectors and pulls have expected useful lives of approximately 15 to 20 years and we have allocated funds for their replacement in 2018.

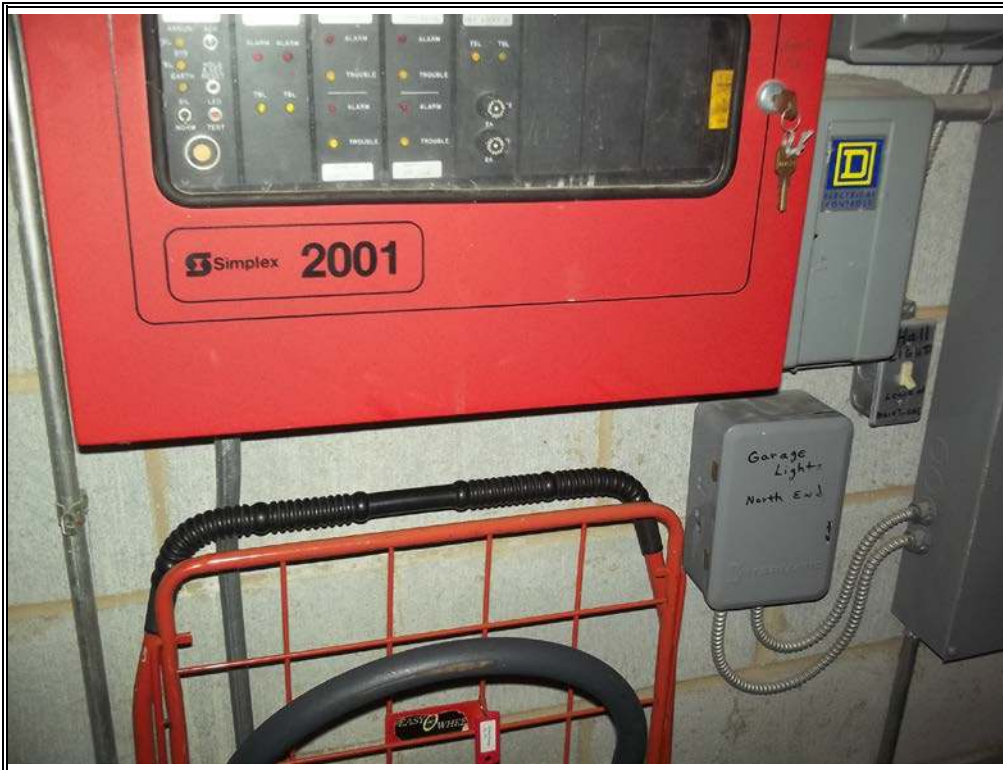
Photo Number
27

Description:
fire alarm control
panel

The Simplex model 2001 fire alarm/life safety system includes a fire alarm control panel located in the electrical room and smoke detectors and pulls in the common areas. It is likely that the fire alarm control panel will require significant repairs or upgrade on an approximately 20-25 year cycle. We have allocated funds for these repairs beginning in 2018.

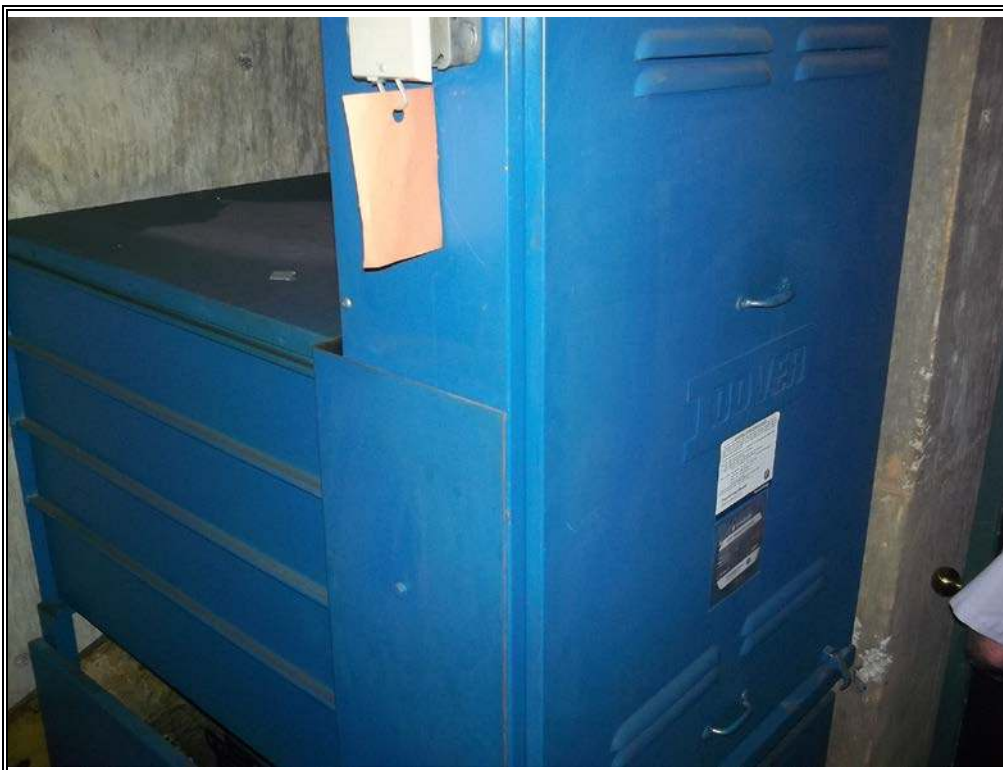
Photo Number
28

Vertical transportation in the building is provided by a Dover hydraulic elevator with a 25 horsepower motor and control panel located in an elevator room at the bottom floor. The elevators appeared to be operating smoothly and inspections were current. The elevator drive motor, controls, cables and door operators have varying useful lives and components are typically replaced as needed. We have included an allocation of funds for replacing the controls, motors/pumps on a 25 year cycle beginning in 2018.

Description:
hydraulic elevator
motor and controls

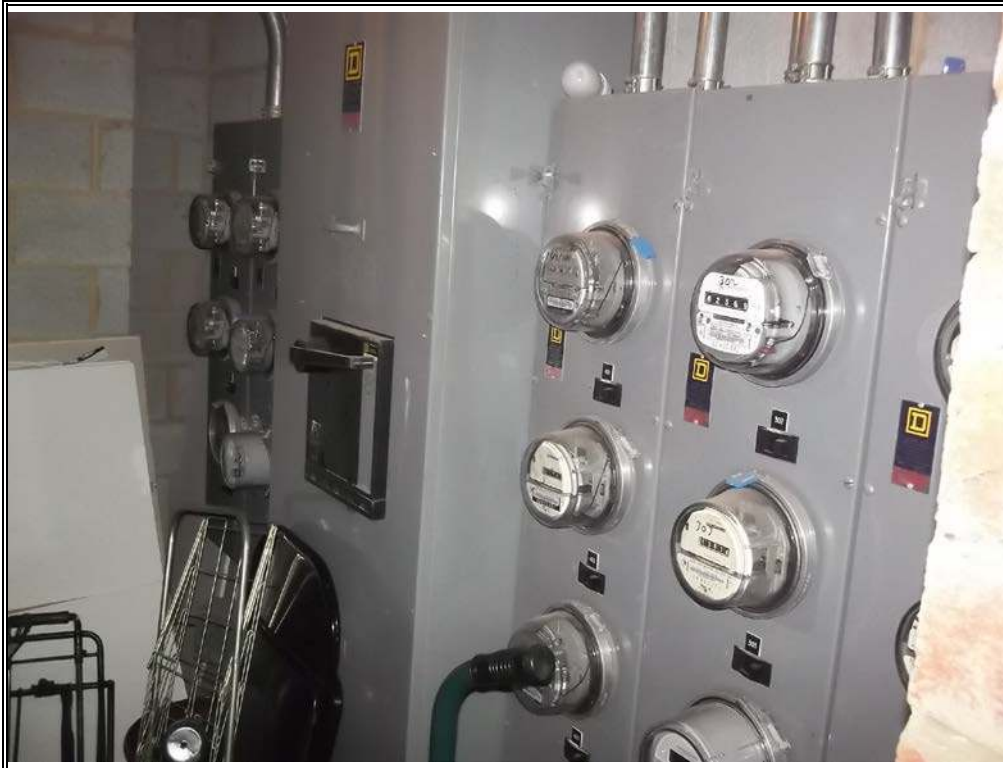
Photo Number
29

Description:
Main electrical
gear and metering

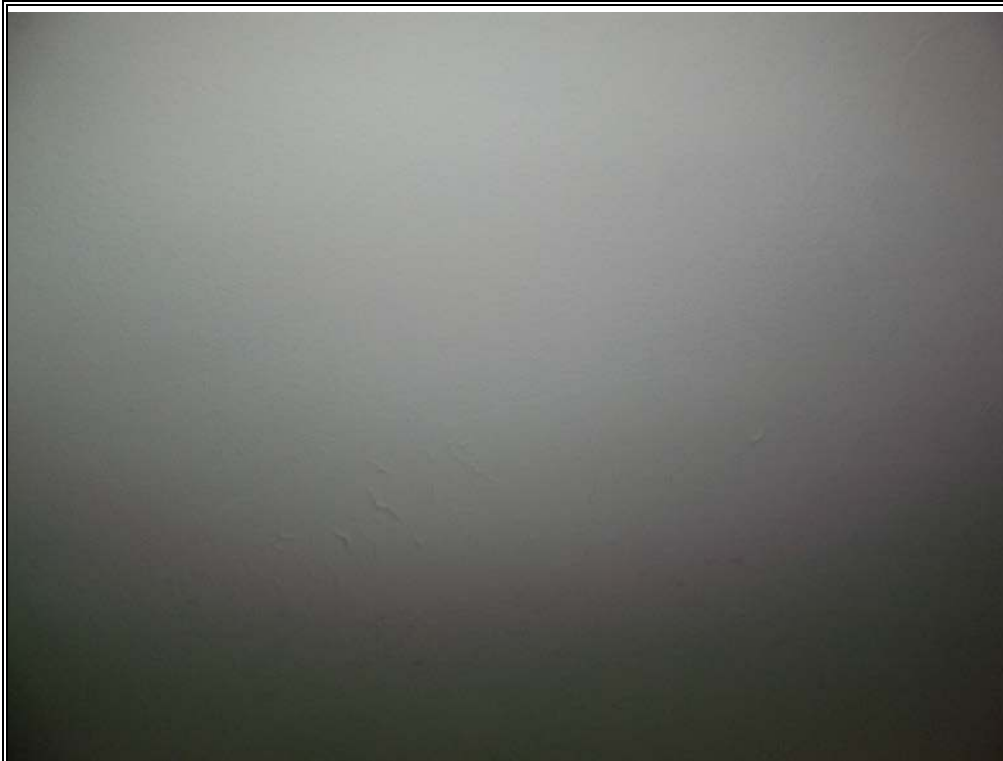
Photo Number
30

Description:
Some paint flaking
on drywall at main
entrance
